**Drumbrae, near Stirling:
Historic Environment Assessment & Survey**

Appraisal

issued 1st December 2023

on behalf of University of Edinburgh

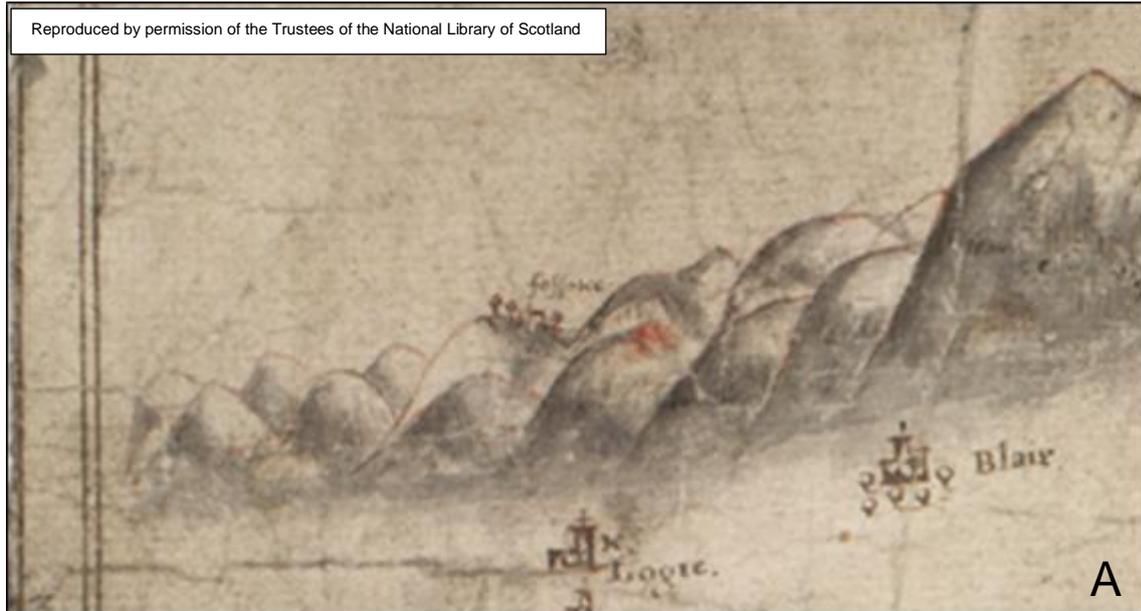
Figure 1: Extracts from John Adair's Maps a) 'A map of Strath Devon ...' (1681) b) 'A Mapp of Clakmanan Shire' (1681) c) 'A Mape of the countries about Stirling' (1685)

44. Similarly, the settlement is depicted as 'forssake' in Adair's '*A mapp of Clakmanan Shire*' which was also published in 1681 (Figure 1b). The prominence of Fossachie in the 1680s suggests a prosperous farmstead which is supported by the scale of the ruins depicted on the 1st edition Ordnance Survey map (1856/66). Fossachie was comprised of four smaller farms that were spread around the surrounding area: Cadgerknows, Broomhill, Backadykes and Pitveys (Harrison 2012, 2). The identified small farmsteads reside outwith the assessment area to the north and south of Fossachie except for Backadykes **S11** which was identified through RCAHMS survey on the western slopes of Dumyat to the north-northeast of Fossachie, alongside a possible drove bank.

45. In Adair's 1685 map '*A mape of the countries about Stirling*' (Figure 1c), the area is barren and only distinguishable by the farmsteads of Pendreich and 'Ethra' now known as Airthrey. The distinctive lack of Fossachie representation a mere four years after Adair's previous work showing the farmstead suggests either a map focusing solely on depicting substantial farmsteads or the abandonment of the farmstead. The abandonment of the farmsteads appears unlikely with the representation of 'Fosakie' on Ross's '*A map of Stirling Shire from*

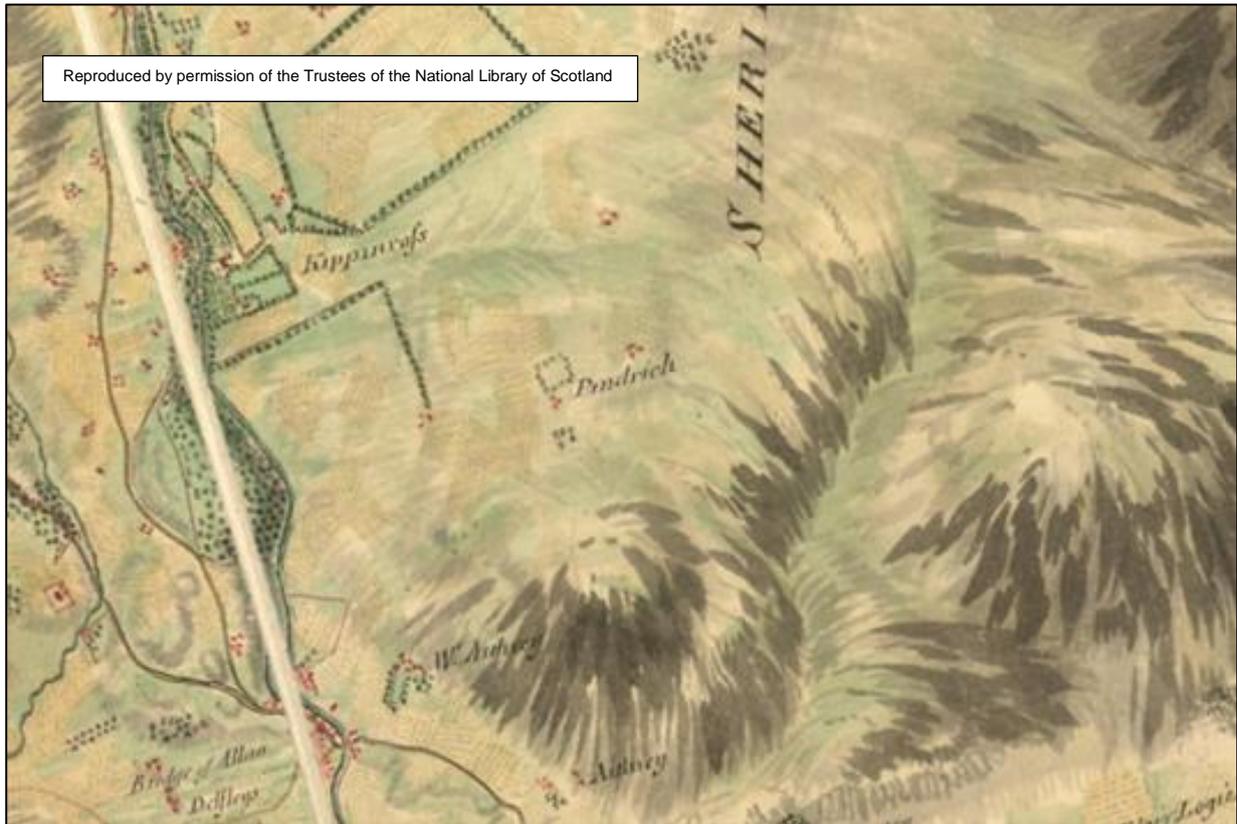
Figure 2a: Extract from Roy's *Military Survey of Highland Scotland* (1747-52)

51. *Roy's Military Survey of Scotland* (Highlands) from 1747-52 (Figure 2a) shows the expansion of 'Pendrich' to the north with three possible dwellings connected with the name. The north-eastern could represent Pendreichmuir farmstead **S22** which abuts the western boundary of the assessment area. Roy depicts two structures and an enclosure that are unnamed, laying to the north-northeast of 'Pendrich' which can be interpreted as Pendreich Mill **S16**. The surrounding area and the area to the south are illustrated as free of settlement and as open hilly ground.

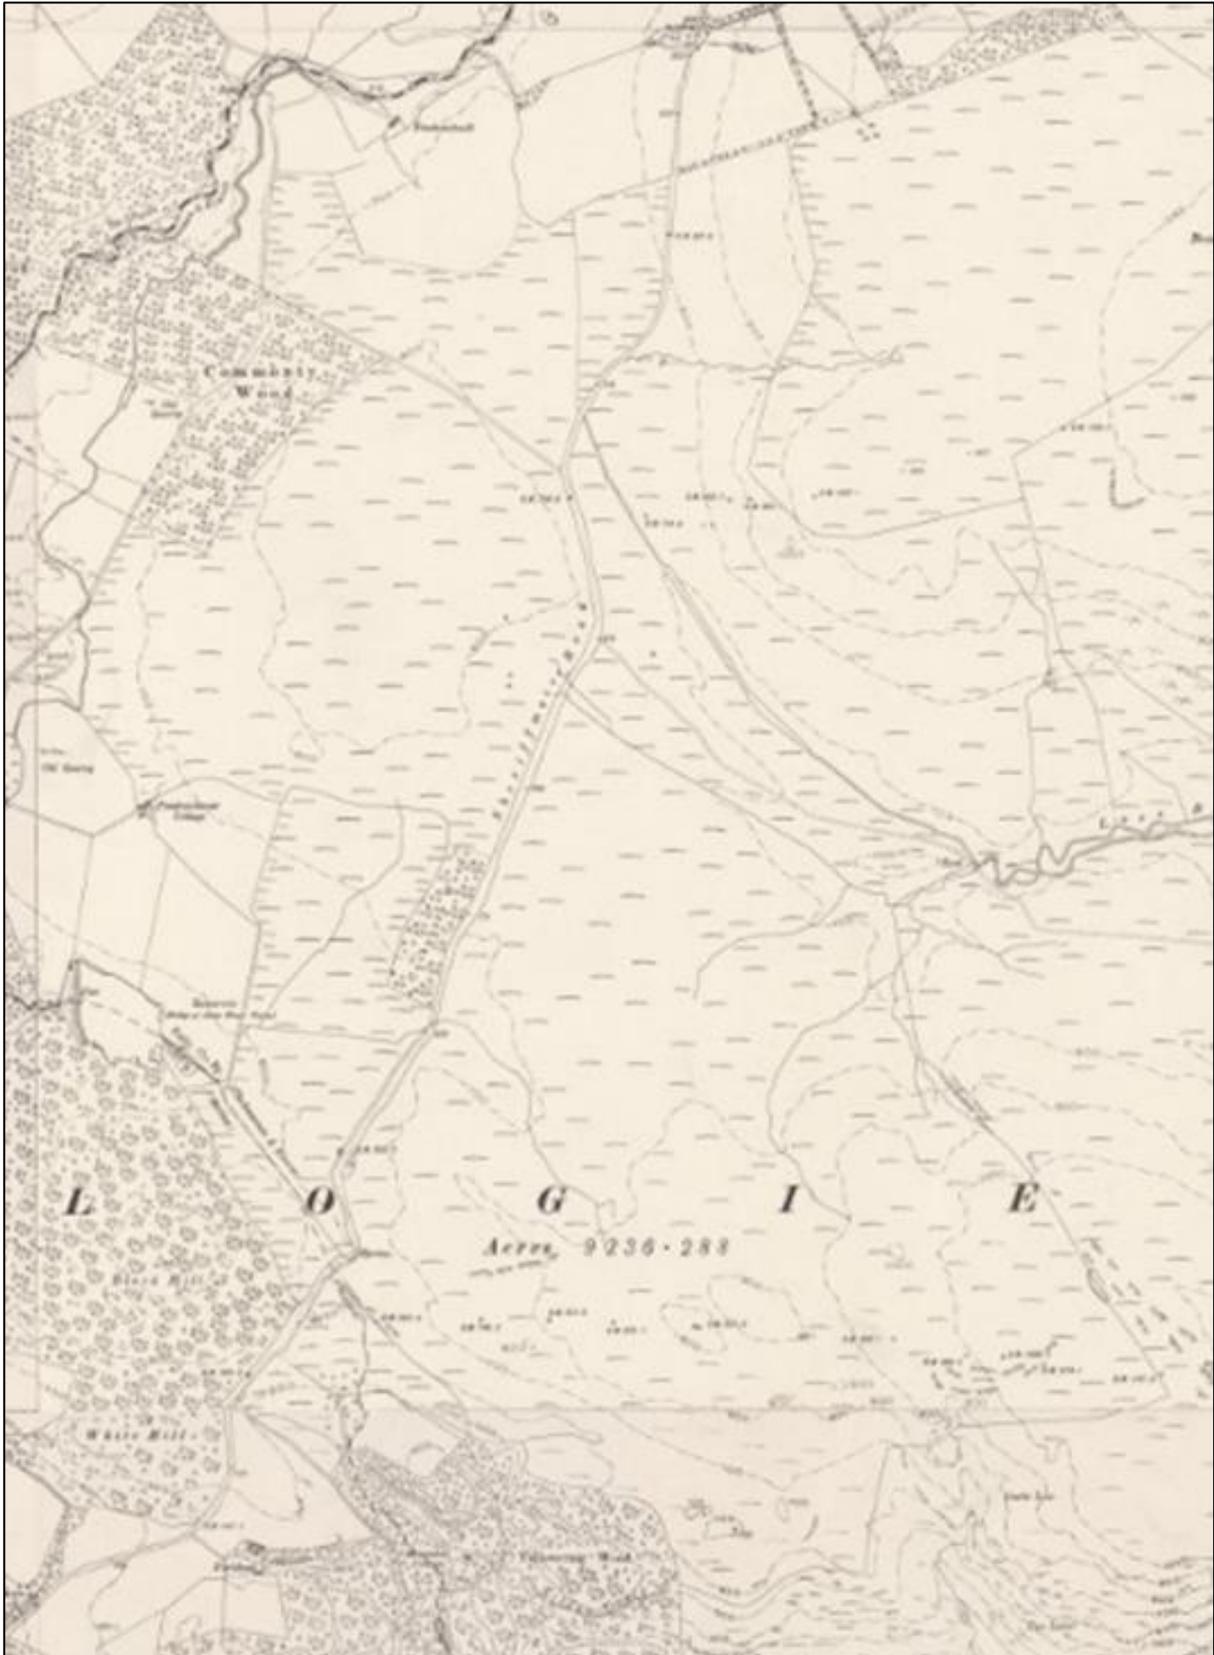
Figure 4: Extract from the 2nd edition Ordnance Survey of 1899-1901.

63. There is little change on the 2nd edition Ordnance Survey 6 inch to the mile (1899-1901) (Figure 4). Parkhead **S9** farmstead has expanded to four separate structures and Fossachie **S5** is illustrated as four structures with associated enclosures, yet the farmstead is unnamed. The boundary banks of **S44** and **S45** are depicted, though **S44** is fragmented. The farm of Parkhead **S9** abuts the designed landscape of Airthrey Castle (IGDL:

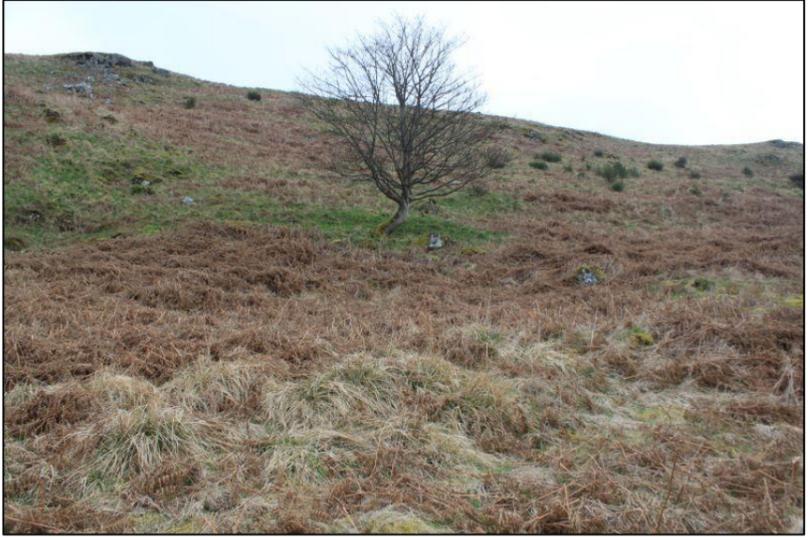
S2	Pendreich Cairns	Canmore: 47127 & 47134 HES: SM2544 SC HER: 1209	<p>Desk Based Assessment</p> <p>Two prehistoric cairns were identified by the RCAHMS in 1954. The cairns are mostly covered in grass, though one has a shallow depression in the centre potentially caused by excavation that reveals a few larger stones. One cairn is noted as measuring approximately 12m in diameter with a maximum height of 0.85m whereas the other measured approximately 7m in diameter with a maximum height of 0.2m. The two cairns have been classified as burial cairns. The two cairns were identified approximately 143m to the south-west of S2.</p> <p>The cairns are not recorded on any historical or modern mapping and are not visible on aerial photography. Two faint mounds are identifiable on LiDAR imagery.</p> <p>Walkover Survey</p> <p>The two cairns were identified through the walkover as turf covered mounds atop a small unnamed summit. The larger cairn to the northwest measured approximately 12m in diameter with a maximum height of 0.7m, multiple large stones were robbed from the centre of the cairn. The smaller cairn, located approximately 8m to the southwest of the larger, measured approximately 7m in diameter and was greatly denuded, surviving to a maximum height of 0.2m.</p>	NS 81248 99230

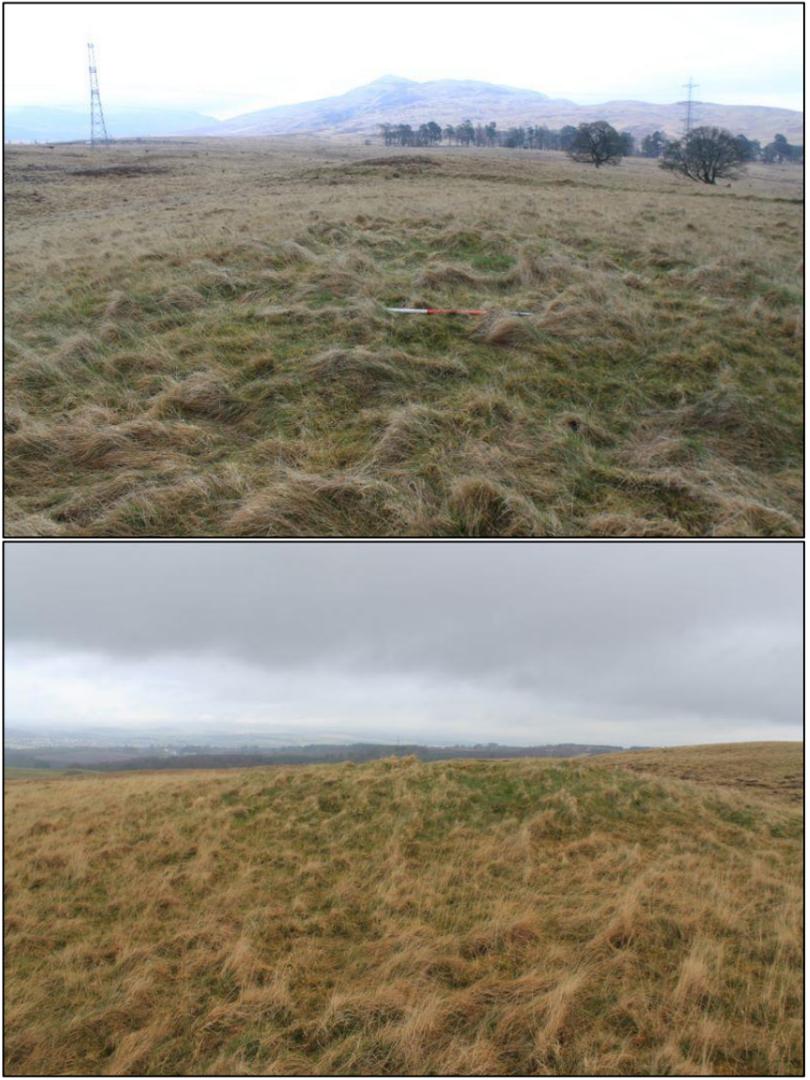
No	Site	HER Ref:	Description	NGR	Image from Site Inspection
S3	Pendreich Cairn	Canmore: 47119 HES: SM2537 SC HER:1223 & 1232	<p>Desk Based Assessment</p> <p>A possible prehistoric burial cairn was identified by RCAHMS in 1954. The cairn was identified approximately 143m to the northeast of S2. The mound measures approximately 6m in diameter and has a height of 0.27m.</p> <p>The cairn is not recorded on any historical or modern mapping and is not visible on aerial photography. A faint mound is identifiable on LiDAR imagery.</p> <p>Walkover Survey</p> <p>The single cairn was identified during the walkover as a turf covered mound. The cairn measures approximately 6m in diameter and had a surviving maximum height of 0.35m. S27 was identified 18m to the east of the cairn.</p>	NS 81246 99382

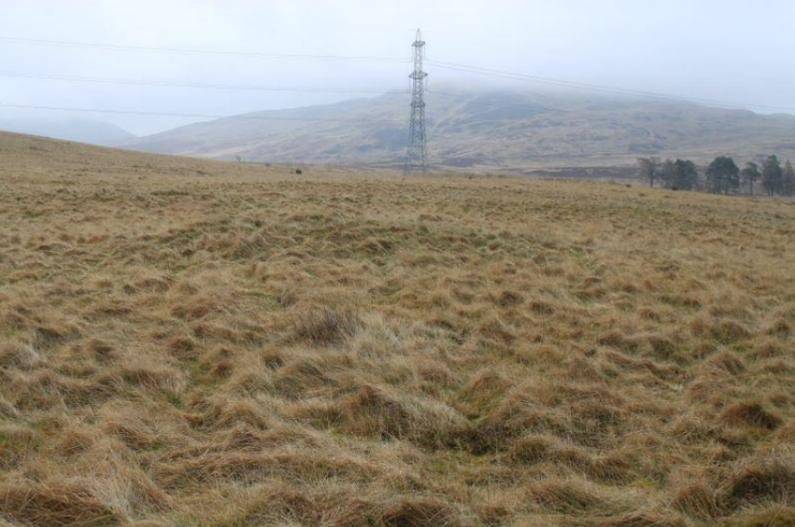
S4	Pendreich Standing Stone	Canmore: 47124 HES: SM2545 SC HER: 1229 & 1229.01	<p>Desk Based Assessment</p> <p>A fallen standing stone was identified by RCAHMS in 1954. The four-sided pillar measures 4m in length with a width of between 0.4m to 1.4m.</p> <p>The standing stone is not recorded on any historical or modern mapping but is visible on aerial photography and LiDAR imagery.</p> <p>Walkover Survey</p> <p>The fallen standing stone was identified during the walkover as a large pillar measuring 4.40m from north to south by 1.27m transversely. A collection of stones was identified on the western side of the stone ranging in sizes from 0.18m-0.49m by 0.27m -0.37m by a height of 0.09m-0.17m.</p>	NS 81376 99671

103. Please note that the scheduled area for **S4** as depicted by HES wholly misses the surveyed location of the fallen standing stone. We recommend that **both** the HES depiction of the scheduled area and our surveyed location (being the same size as the HES scheduled area but centred on the standing stone) are treated as scheduled areas with protection buffers applied to both.

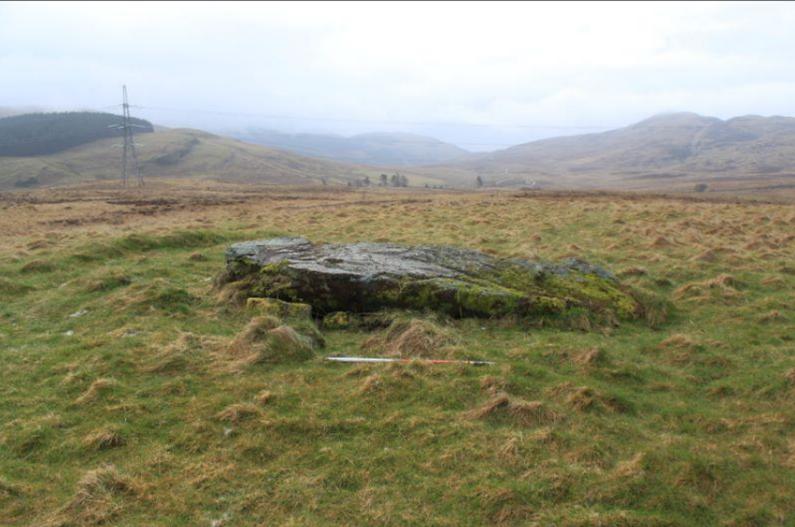
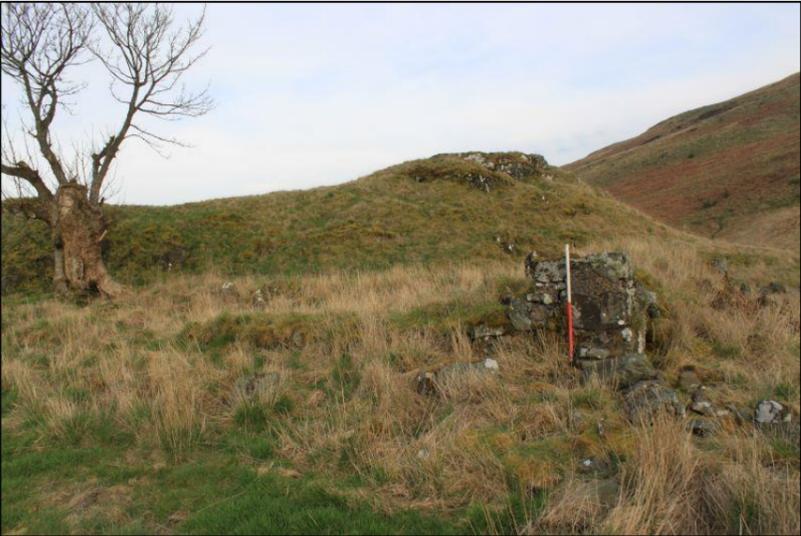
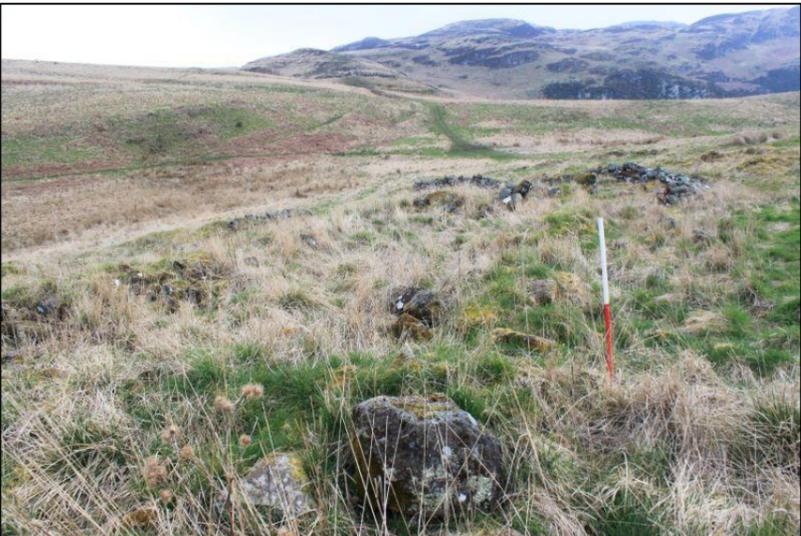
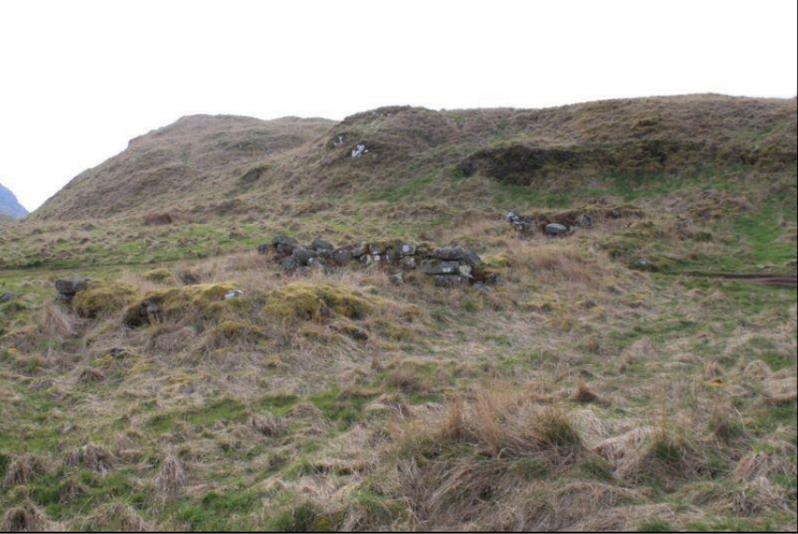
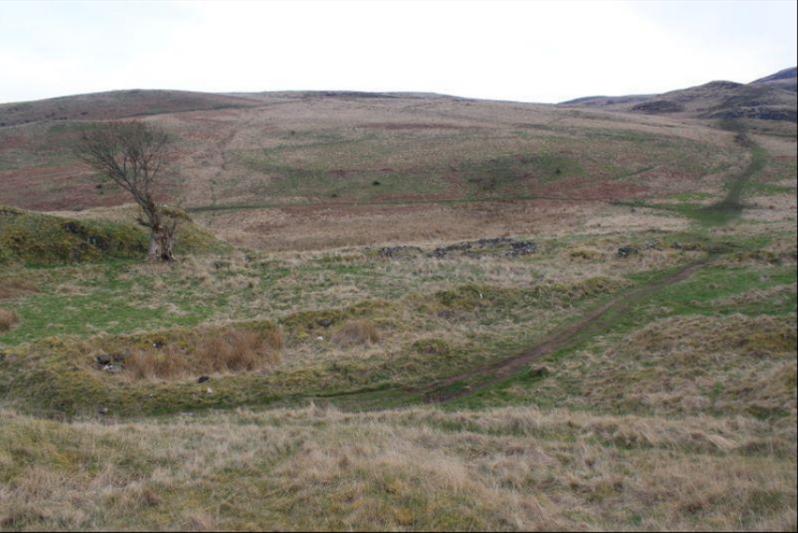
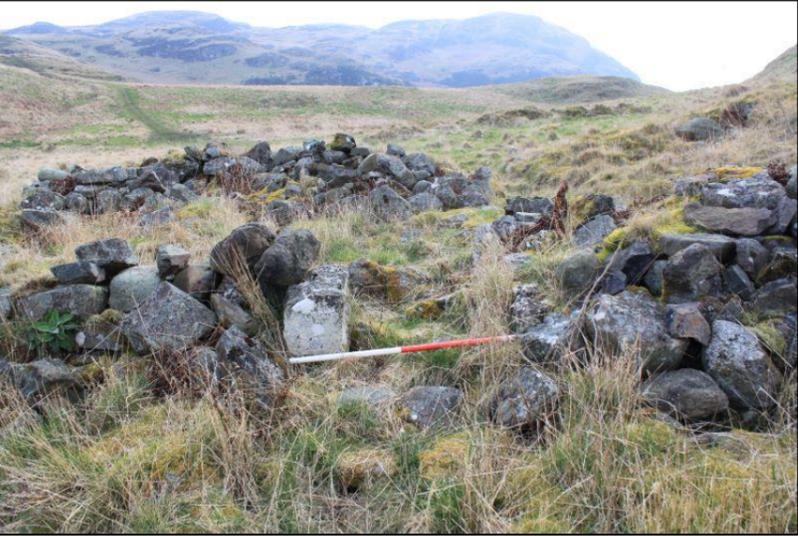
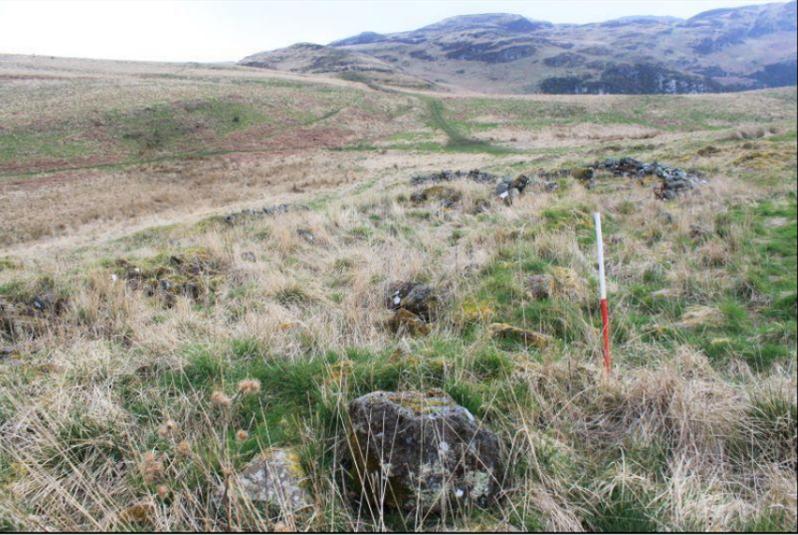
No	Site	HER Ref:	Description	NGR	Image from Site Inspection
S5	Fossachie Farmstead	Canmore: 111988 SC HER: 3498.01 & 3498.02	<p>Desk Based Assessment</p> <p>A farmstead named ‘Fassake’ and ‘Fossake’ are depicted on Adair’s two maps of 1681 as potentially two buildings flanked by trees, however, the farmstead is not depicted on Adair’s map of 1685. The farmstead is not depicted on subsequent historical mapping until the 1st edition Ordnance Survey (1865/1866) where the settlement is noted as ‘Ruins’ The 1st ed Ordnance Survey map illustrates the farmstead as comprised of four roofless buildings with an associated enclosure.</p> <p>The farmstead is depicted on subsequent historical mapping as an unnamed settlement comprised of two rectangular buildings: one with four compartments and one with two compartments.</p> <p>The farmstead is easily identifiable on aerial photography and LiDAR Imagery. LiDAR Imagery identifies the farmstead as seven structures ranging in size with four associated enclosures.</p> <p>Walkover Survey</p> <p>The settlement was identified on the walkover survey as eight turf and stone structures with associated banked enclosures.</p> <p>The settlement comprised of three larger structures (S5.1 -S5.3), two running ENE-WSW and one running NNW-SSE, the structures S5.1 and S5.3 appeared to have two compartments whereas S5.2 appeared to have four compartment with a modern track running through the centre. S5.1 is the best surviving structure within the settlement with the eastern corner of the structure surviving to a maximum height of 1.05m.</p> <p>The structures S5.4 and S5.5 were identified as single compartment structures whereas structures S5.6 and S5.7 were identified as small structures, possibly for storage within the farmstead.</p> <p>One of the possible structures was identified as a quarry scoop close to S5.3.</p> <p>All structures were comprised of dry-stone wall with turf overlaying the walls, the walls measured and width of between 0.75m to 1.15m with a surviving maximum height of between 0.4m to 1.05m.</p> <p>The settlement had seven banks that connected the structures and created enclosures or yards within the farmstead. These banks were a mixture of dry-stone banks and turf banks measuring a width of 0.9m to 1.05m and a maximum height of between 0.45m to 0.77m.</p>	NS 82122 97420	<p>S5.1</p>

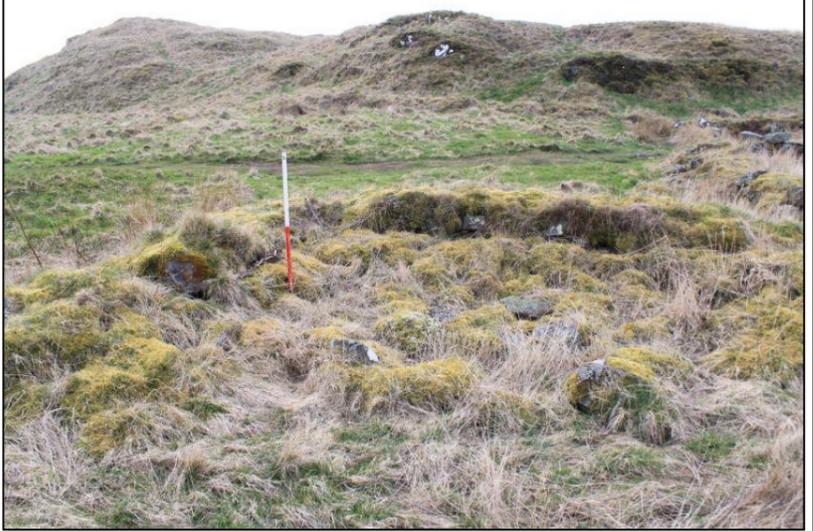
S6	Yellowcraig Wood Structure	-	<p>Desk Based Assessment</p> <p>A sub-square structure was identified through aerial photography and LiDAR imagery to the south of S5 by 37m. The structure measures 9.1m from NW to SE by 7.6m transversely.</p> <p>The structure was not depicted on any historical or modern mapping.</p> <p>Walkover Survey</p> <p>The walkover survey identified this as a turf covered enclosure. The banks were 0.95m wide by 0.3m high.</p>	NS 82111 97346

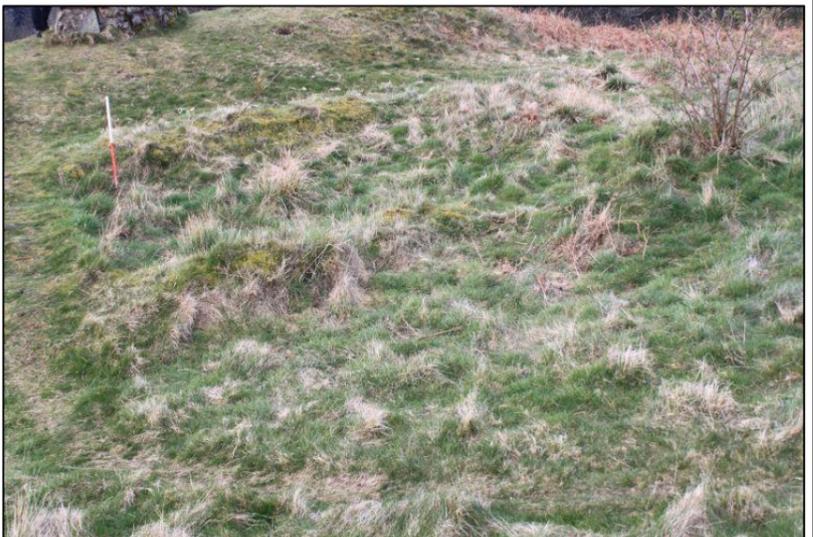
No	Site	HER Ref:	Description	NGR	Image from Site Inspection
S7	Dumyat Hill Structure & Enclosure	-	<p>Desk Based Assessment</p> <p>A rectangular structure with associated enclosures was identified through aerial photography and LiDAR imagery. The structure measures 14.4m from NNW to SSE by 7.9m transversely. Two sub-square enclosures are attached to the NW with an irregularly shaped enclosure attached to the NE. A rectangular structure S8 was identified 55m to the SE of S7.</p> <p>The structure and enclosures are not depicted on any historical or modern mapping.</p> <p>Walkover Survey</p> <p>The site was identified as a rectangular structure with two sub-square enclosures attached to the NW and a partial enclosure to the NE. The structure comprised turf banks measuring 1.45m wide, with possible tumble, and 0.5m at maximum height.</p>	NS 82385 97617

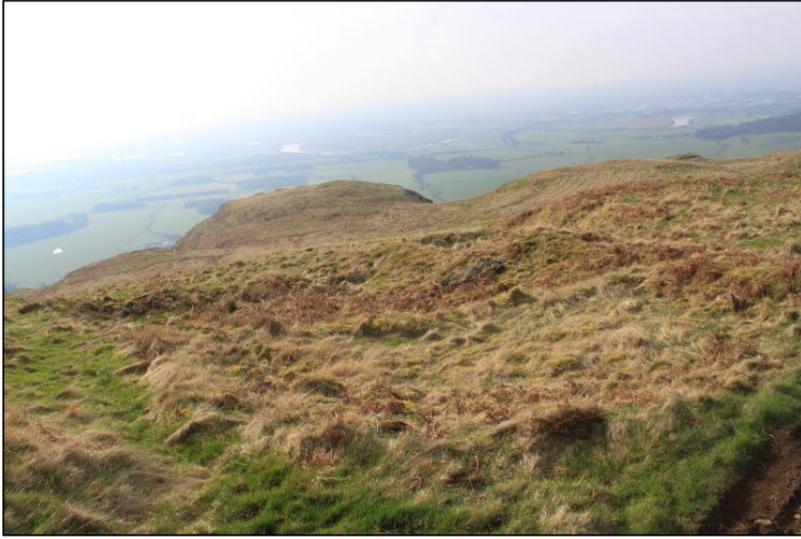
S8	Dumyat Hill Structure	-	<p>Desk Based Assessment</p> <p>A rectangular structure was identified through LiDAR Imagery. The structure measures 12m from NW to SE by 7.6m transversely. The structure was identified 55m to the SE of S7.</p> <p>The structure and enclosures are not depicted on any historical or modern mapping or aerial imagery.</p> <p>Walkover Survey</p> <p>The structure was identified as very ephemeral up close yet was perceivable from afar.</p>	NS 82447 97582

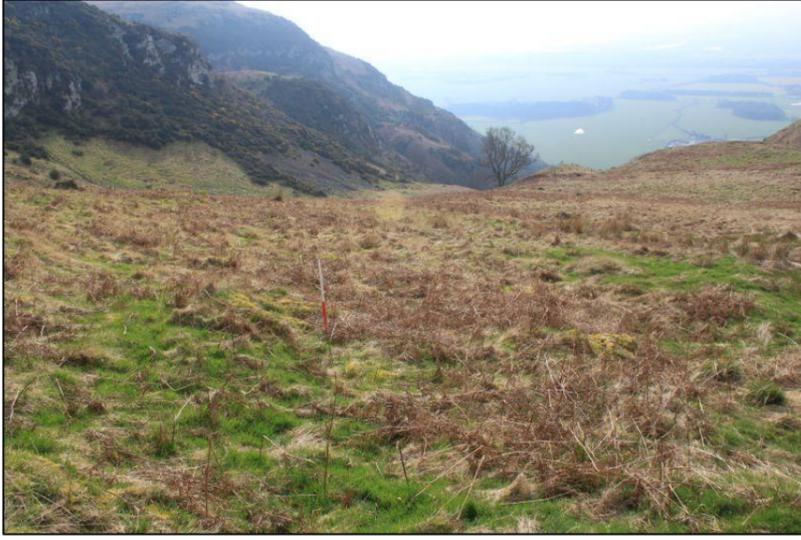
S9	Parkhead Farmstead	Canmore: 162793 SC HER: 4625	<p>Desk Based Assessment</p> <p>A farmstead named 'Parkhead' is first depicted on Grassom's (1817) map 'To the Noblemen and Gentlemen of the County of Stirling' as five buildings with four conjoined to create a central courtyard. The farmstead is depicted on the 1st edition Ordnance Survey (1865/66) as two roofed structures and three enclosures with a track running NW to join Sheriffmuir Road.</p> <p>The farmstead gains two additional roofed structures in the 2nd ed Ordnance Survey (1899-1901). The farmstead is identifiable on both aerial and LiDAR imagery.</p> <p>The farmstead is currently occupied.</p> <p>Walkover Survey</p> <p>The farmstead is an active dwelling with horses and sheep with lambs in all fields surrounding it.</p>	NS 81059 97357

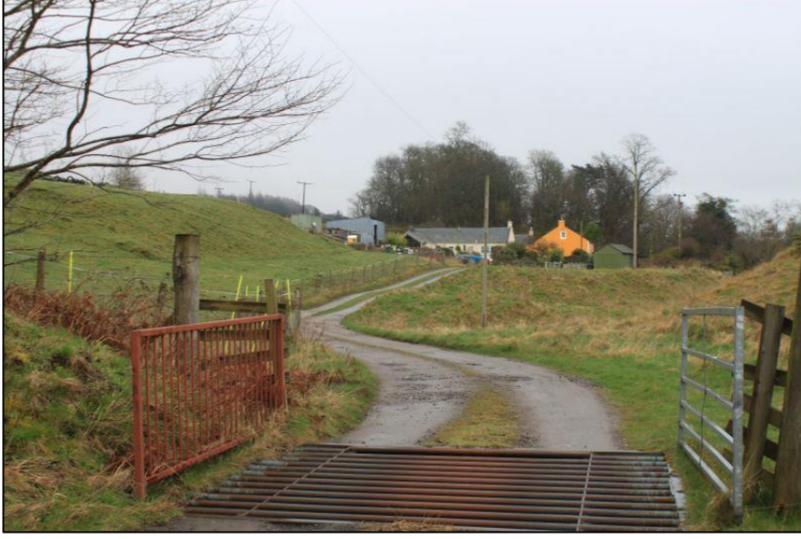
No	Site	HER Ref:	Description	NGR	Image from Site Inspection
S10	Dumyat Hill Structure	-	<p>Desk Based Assessment</p> <p>A rectangular structure was identified through LiDAR Imagery. The structure measures 7.7m from NW to SE by 10.6m transversely. The structure was identified 52m to the SW of S11.</p> <p>The structure and enclosures are not depicted on any historical or modern mapping or aerial imagery.</p> <p>Walkover Survey</p> <p>The rectangular structure was identified during the field survey as a turf covered structure. The structure was easily identifiable in the landscape with banks measuring a width of 1.7m (including tumble) at a maximum height of 0.55m. The structure was identified off a modern thin track that runs directly through S11 and past S10.</p>	NS 82628 97831

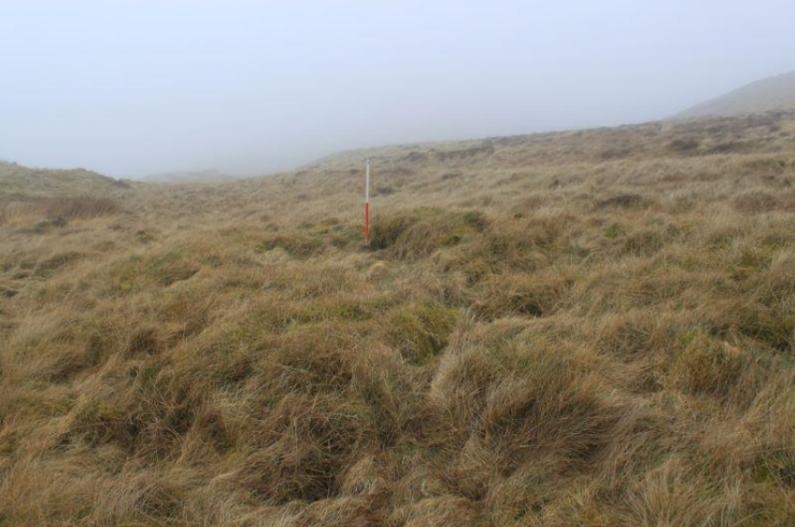
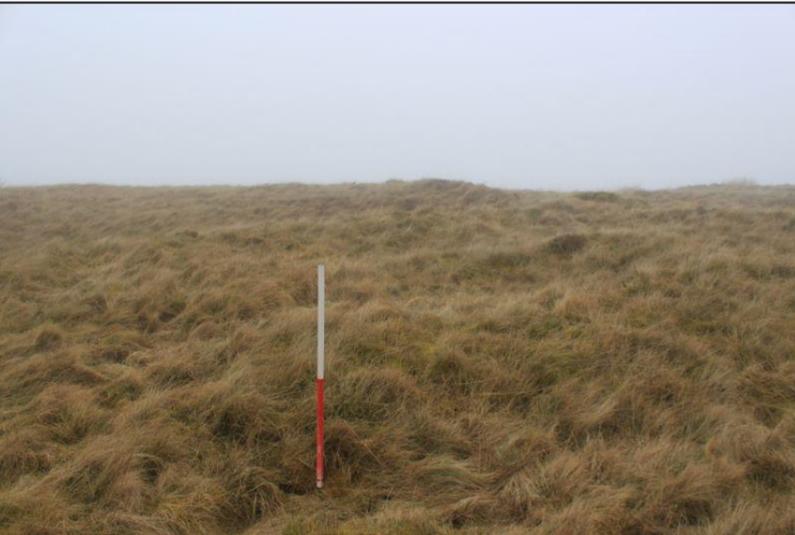
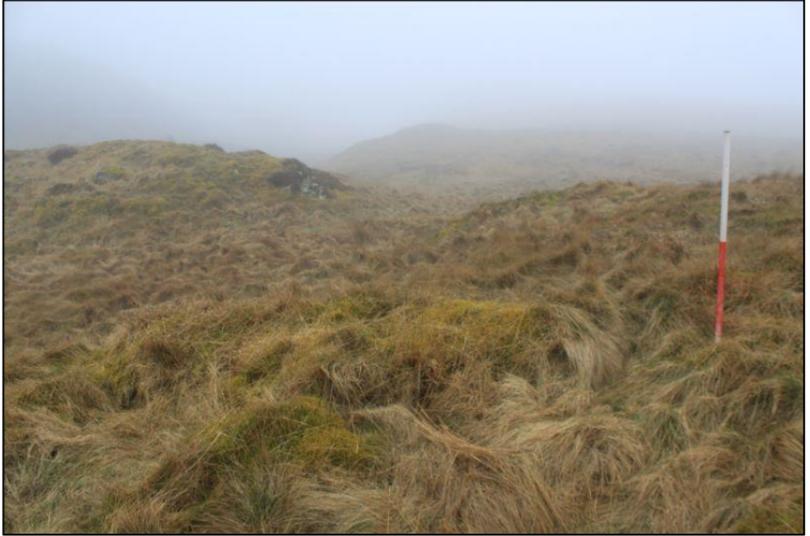
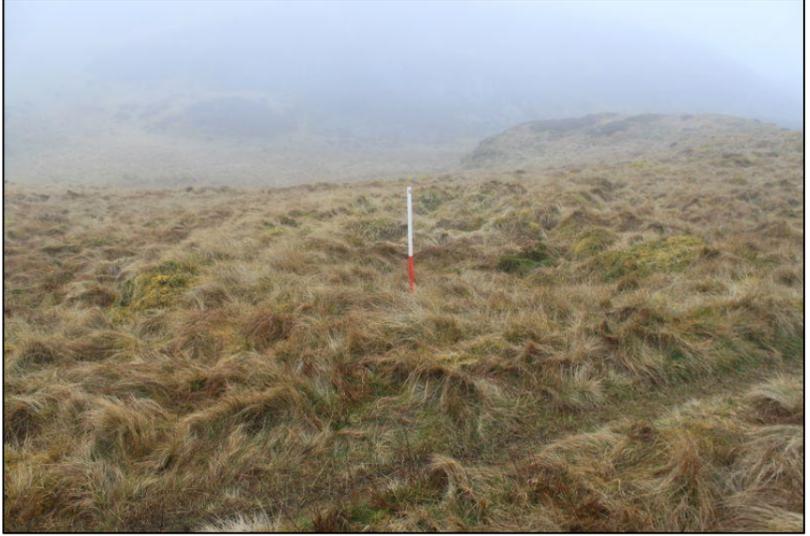
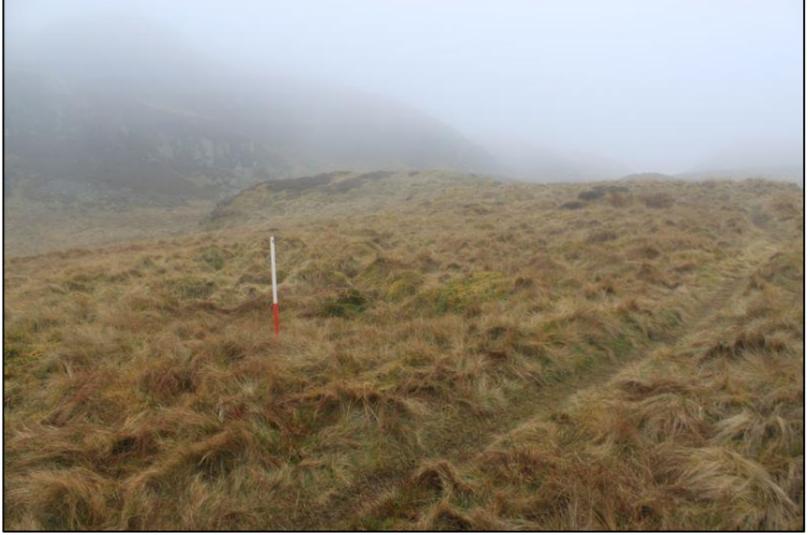
S11	Backadykes Farmstead	-	<p>Desk Based Assessment</p> <p>A possible drove wall was identified in 1996 alongside a rectangular stone house. The house was identified as a 18th century occupied structure. An investigation completed by RCAHMS through aerial photography interpretation identified the building as a two compartment sub-rectangular building. A possible second enclosure was identified to the S of the main structure. The remains are believed to be the ruins of Backadykes, which formed part of Fossachie during the 18th century and was probably abandoned in the late 1760s.</p> <p>The possible farmstead comprised of five unroofed structures and associated field banks were identified through LiDAR imagery. The settlement is not depicted on historical or modern mapping.</p> <p>The settlement sits 52m to the NE of S10 and 68m to the S of S12.</p> <p>Walkover Survey</p> <p>Six structures were identified with three associated banks during the walkover. The structures were all turf covered banked sub-rectangular structures. The structures S11.1 and S11.3 are orientated NE to SW whereas S11.5 and S11.6 were orientated NW to SE and S11.2 & S11.4 were orientated N to S.</p> <p>S11.2, S11.3 and S11.5 appeared to have two compartments with S11.2 having two 2m wide compartments.</p> <p>The banks of the structures measured a width of between 1m to 1.3m with a maximum height of between 0.25m to 0.4m.</p> <p>The banks in the area S11.7 all measured approximately 1.3m in width and 0.4m in height.</p> <p>The drove wall was identified as a turf covered bank that curved from a modern track towards the north.</p>	NS 82630 97927	<p>S11.1</p>

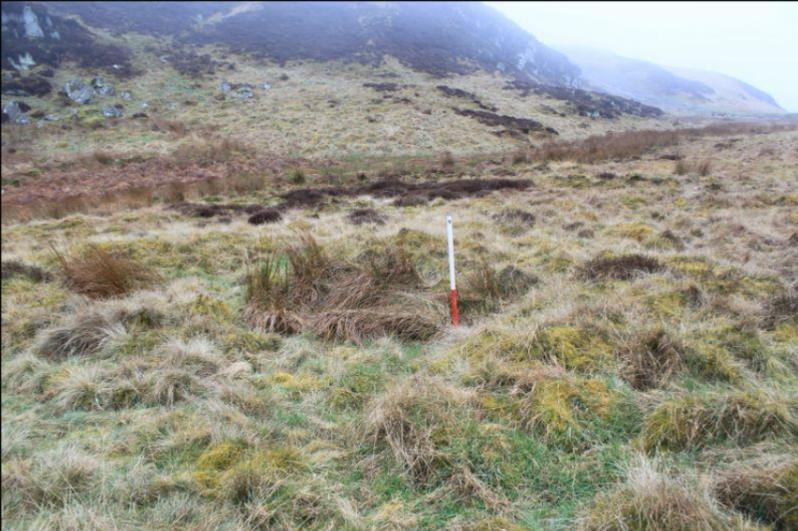
S12	Dumyat Hill Structure	-	<p>Desk Based Assessment</p> <p>A rectangular structure was identified through LiDAR Imagery. The structure measures 16.1m from NNE to SSW by 8m transversely. The structure was identified 68m to the N of S11.</p> <p>The structure and enclosures are not depicted on any historical or modern mapping or aerial imagery.</p> <p>Walkover Survey</p> <p>The rectangular structure was identified as an ephemeral structure during the walkover that was perceivable from afar.</p>	NS 82642 98029

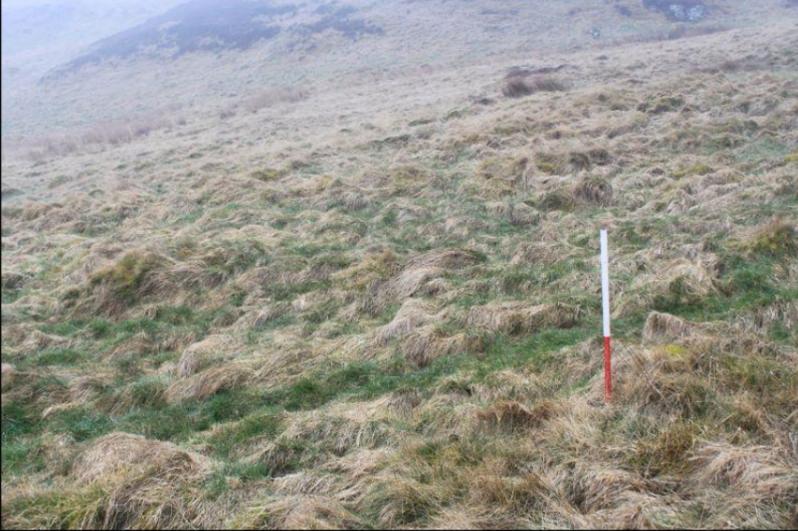
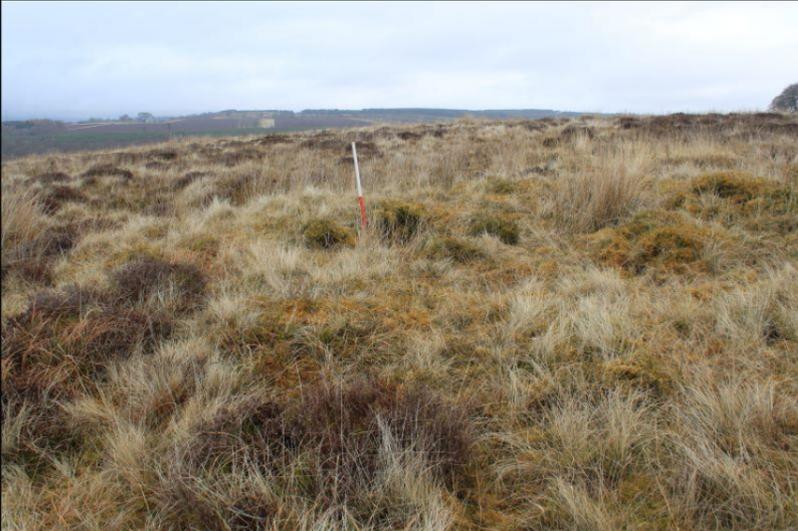
S13	Cuparlaw Wood Trench	SC HER: 4964	<p>Desk Based Assessment</p> <p>Two linear earthworks were identified through LiDAR imagery on the western side of the assessment area.</p> <p>S13.1 was identified as a traversed linear depression running on a single alignment for a length of 180m from SSE to NNW with a width of 5m.</p> <p>S13.2 was identified as a traversed linear depression running for a length of 280m from SSE to N in both straight and curving sections. Two larger earthworks were noted on the alignment of the linear depression, and two smaller extensions. The complex as a whole had a width of between 4m to 14m.</p> <p>The earthworks were provisionally identified as early 20th century military practice trenches. They are not depicted on historical or modern mapping. However, one of the larger earthworks has been identified in the Stirling Council HER as a 'roundhouse'.</p> <p>Walkover Survey</p> <p>S13.1 was a 180m long NW to SE aligned stepped or traversed trench with two slight banks on either side. This traversed trench ran through rig block CS, breaking for the minor burn, before climbing the slope to end at a break in a section of bank</p>	<p>S13.1</p> <p>NS 81063 99280 to NS 80976 99439</p> <p>S13.2</p> <p>NS 81214 99324 to NS 81208 99508</p>	<p>S13.1</p>

No	Site	HER Ref:	Description	NGR	Image from Site Inspection
			<p>S45. There was no evidence noted of the adaptation of the slight ditch to the rear, upslope, of this bank that ran northeast to southwest. The trench was shallow, up to 0.5m deep, and reed-filled – the ground covered by rig block CS is wet. In form the trench is typical of a fire trench used in military defences of the early 20th century</p> <p>Some 120m to the northeast of the first trench, on higher ground, was a complex of earthworks S13.2. This was formed of six elements. From the northern end, there is a straight section of traversed trench (fire trench) running southwest for 70m until it meets the northeastern slope of a minor ridge. The stepped trench then curves for 100m, on the contour, around the northwestern end of the ridge before entering a larger, subrectangular earthwork. The stepped trench was flanked by minor banks, 4.3m in width and has a crenellated appearance in plan though was deeper (up to 0.75m) and dry. In its curved section, the trench cut through rig block CM and a section of bank S45.</p> <p>The subrectangular earthwork was defined by a bank with a trench to the rear, interior, that left a central block at a higher level. This structure was between 17m and 14 m across and was entered by the fire trench at the north angle. The interior of the earthwork measured at minimum 10.7m in diameter with the bounding banks being at least 1.3m wide. The trench to the rear of the banks meant this combined feature gave an internal height of 0.42m and an external height of 0.15m. This feature was included in the Stirling HER as a 'roundhouse' (Stirling HER 4964). The form of this sub-rectangular feature is reminiscent of an outpost piquet as depicted in the Manual of Field Engineering (War Office 1911, Plate 30).</p> <p>There are three additional features along the main fire trench. As the northern section of the traversed trench meets the ridge, there is subcircular banked earthwork set to the southeast of the trench. Some 13m in diameter, there is a trench set to the rear, the interior of the bank that is accessed from the main traversed trench from the north, while a central column of ground has been left unexcavated. The banks measured a width of 1.2m and had a surviving height of 0.2m. This may be a covered shelter or kitchen, note this is set behind the fire trench. A further two extensions to the traversed trench were noted as this trench arced around the end of the ridge, one expanding the trench to the north, the other to the west.</p> <p>A second traversed trench runs southwest for 80m from the subrectangular earthwork at the southern end of the first traversed trench. This second traversed trench is slighter, harder to recognise in the landscape and appears to have been overlain by the subrectangular earthwork.</p>		<p>S13.2</p>

79. During the walkover, two areas of possible military practice trenches were investigated (**S13.1** & **S13.2**). The first trench encountered was **S13.1** which was a 180m long northwest to southeast aligned stepped or traversed trench with two slight banks on either side. This traversed trench ran through rig block **CS**, breaking for the minor burn to the southeast, before climbing the slope to end at a break in a section of bank **S45**. There was no evidence noted of the adaptation of the slight ditch to the rear, upslope, of this bank that ran northeast to southwest. The trench was shallow, up to 0.5m deep, and reed-filled – the ground covered by rig block **CS** is wet. In form the trench makes a series of regular 90° turns or traverses, giving a crenellated appearance in plan. This form is typical of a fire trench used in military defences of the early 20th century.

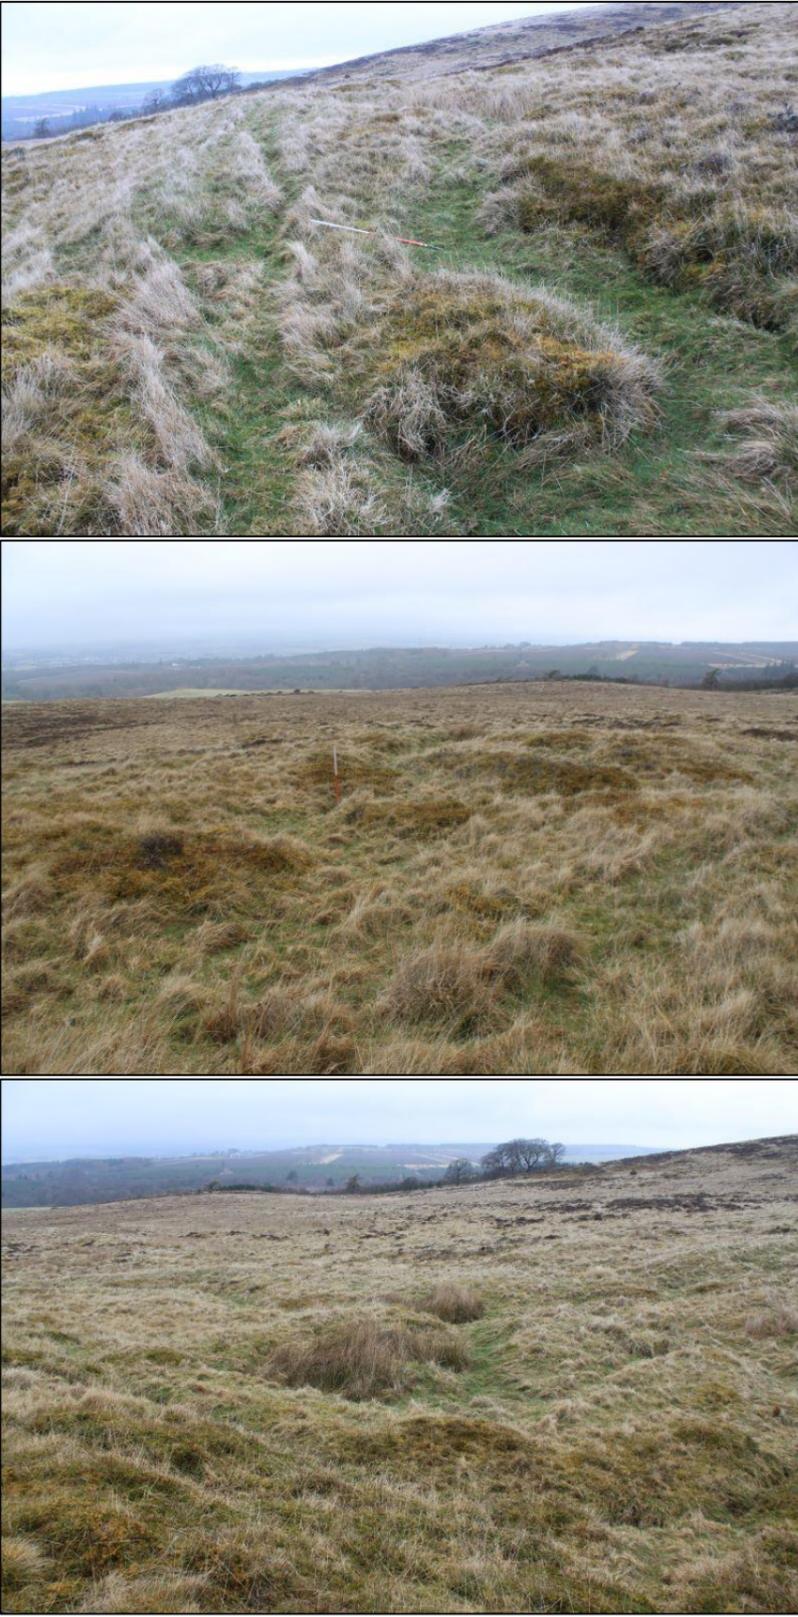
No	Site	HER Ref:	Description	NGR	Image from Site Inspection
S14	Cuparlaw Wood Sheepfold	-	<p>Desk Based Assessment</p> <p>A sub-square structure was identified through aerial photography and LiDAR imagery to the south-southwest of S13 and to the northeast of S22 by 179m. The structure measures 11.2m from NW to SE by 8.7m transversely.</p> <p>The structure was not depicted on any historical or modern mapping.</p> <p>Walkover Survey</p> <p>The enclosure was identified in the walkover survey as an ephemeral banked D-shaped enclosure in the landscape which has a diameter of 8.85m with banks measuring 1.75m wide.</p>	NS 81047 99224

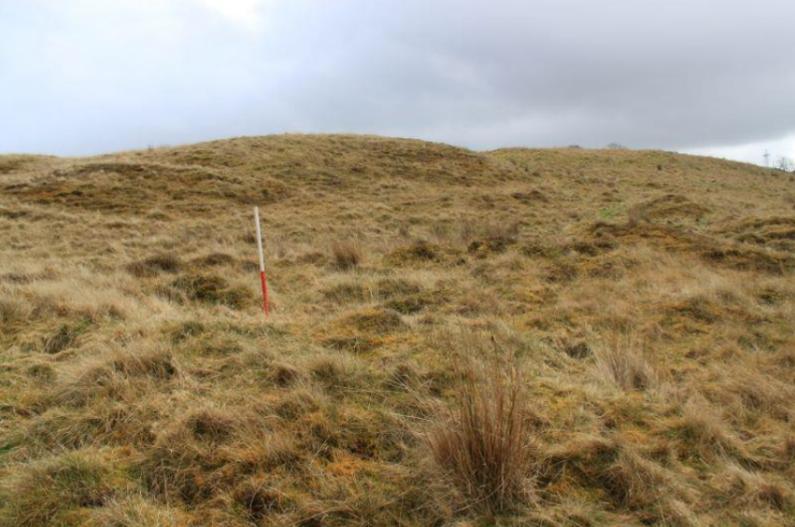
S15	Wharry Burn Lade	Canmore: 348827	<p>Desk Based Assessment</p> <p>The lade associated with Wharry Burn is first depicted on the 1st Ed Ordnance Survey (1865/66) as running from the north-east to the north-west before curving running south for a length of approximately 788m. The lade cuts out of the assessment area before returning to the assessment area for a stretch of 228m from north to south. The lade is connected to Pendreichmill S16 through a sluice that sits to the north of the mill.</p> <p>The land is noted as 'Mill Lade (Disused)' on modern mapping and is visible on both aerial and LiDAR imagery.</p> <p>Walkover Survey</p> <p>The lade was identifiable predominately in the northern area where it runs from a sluice at Wharry Burn before following the natural contours of the hill side as a turf covered bank. The lade had an average width of 2.3m with a surviving maximum height of 0.25m and at points, the turf had naturally been removed by rain to reveal a large metal pipe running along the width.</p> <p>Within the western area, the lade was identified as a bank predominately covered in gorse clusters.</p>	<p>Northern Area</p> <p>NS 81471 00732 to NS 81073 00368</p> <p>Western Area</p> <p>NS 80746 99538 to NS 80744 99322</p>

71. The lade **S15** associated with Pendreichmill was identified a short distance from the structure as a raised turf covered bank. The turf had deteriorated from the elements in areas revealing a modern manhole as well as a large metal pipe running along the same track as the lade.

111. Wharry Burn lade **S15** is a well-preserved culverted lade that was depicted in the 1st ed Ordnance Survey (1865/66). The lade is distinct as it carves through the landscape making a moderate contribution to the landscape character while it is unlikely to embody complex archaeological information. It has been ascribed Local significance and should be **protected** with a 5m buffer, managed as a clearing and maintained as open space.
