**Drumbrae, near Stirling:
Historic Environment Assessment & Survey**

Appraisal

issued 1st December 2023

on behalf of University of Edinburgh

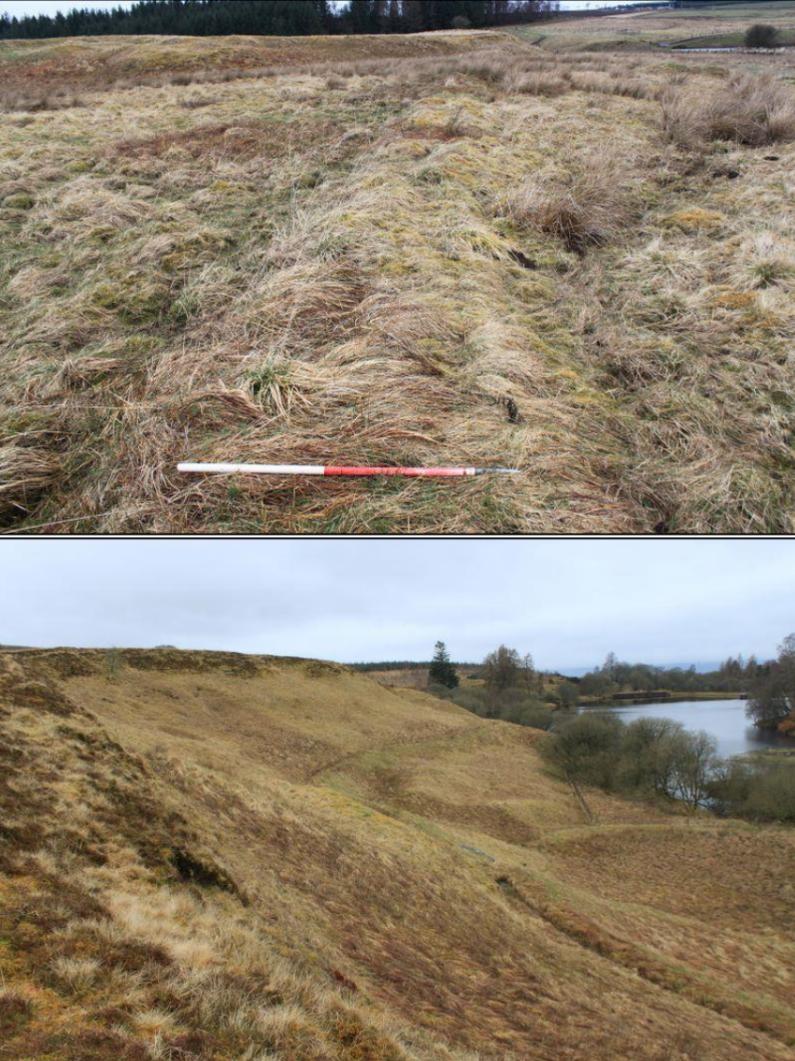
No	Site	HER Ref:	Description	NGR	Image from Site Inspection
S16	Pendreichmill Farmstead	Canmore: 111994 SC HER: 4527	<p>Desk Based Assessment</p> <p>A farmstead comprising of two roofed structures was identified as 'Pendreichmill' on the 1st ed Ordnance Survey (1865/66). A track was illustrated running away from the structure to the northwest before curving to run towards the southwest where it forks into two roads, one running north outside of the assessment area and the other running south before exiting the assessment area. The farmstead was depicted as a single roofed structure in the 2nd ed Ordnance Survey (1899-1901) with an additional track running to the north-northwest out of the area.</p> <p>The farmstead is not depicted on subsequent historical or modern mapping, yet it is identifiable on both aerial and LiDAR imagery as a single building with associated field banks. The structure measures 22.3m from NE-SW by 13.4m transversely.</p> <p>Walkover Survey</p> <p>The farmstead was identified as a single structure with three compartments and a single 'shed' structure attached to the northwest corner. The structure measured 31m from NE to SW by 14.7m transversely. The northernmost compartment was the best surviving with the eastern wall comprising of partly destroyed five rubble courses and rybat stones on either side of possible window. Two remains of door jambs were identified highlighting the southern two compartments. The bank to the SE of the structure was stone built and partly covered in turf, giving the impression of an agricultural enclosure surrounding Pendreichmill.</p>	NS 81502 00666

70. The walkover survey began in the northern section of the assessment area which is predominately filled with large areas of rig and boundary banks. The survey confirmed the presence of Pendreichmill **S16** as a single dilapidated structure, with the additional observation that the structure comprised three main compartments with a small 'outhouse' or 'shed' connected to the northwestern corner of the largest compartment. Much of the original detail was missing from the structure, however, the presence of a window sill and two door jambs was noted.

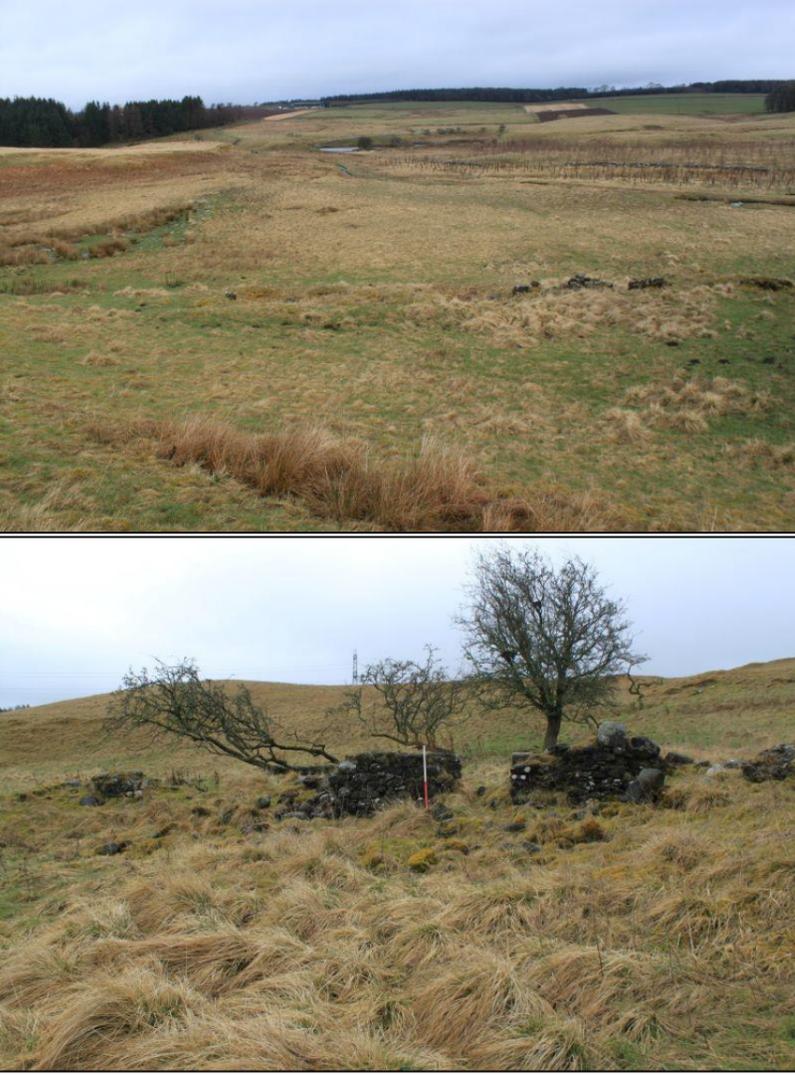
S17	Sheriffmuir Road Enclosure	SC HER: 3496.01 & 3496.02	<p>Desk Based Assessment</p> <p>An enclosure and crop mark are noted in the Stirling Council Historical Environment Record to the immediate south of one of the overhead towers for the Beauldy Denny Overhead line.</p> <p>The enclosure and cropmark are not depicted on any historical or modern mapping and is not identifiable on aerial or LiDAR imagery.</p> <p>Walkover Survey</p> <p>No evidence of an enclosure or crop mark was identified during the walkover survey. There is a possibility for disturbance caused to the archaeological features by the construction of the overhead tower.</p>

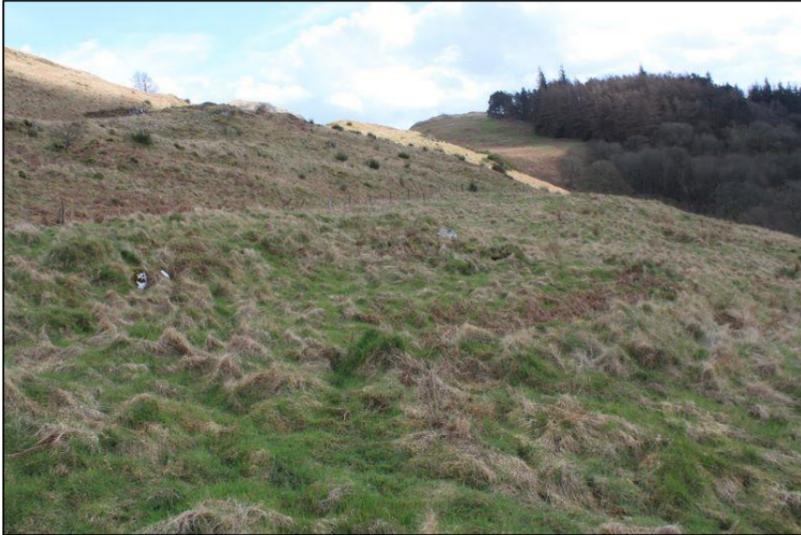
S19	Dumyat Hill Enclosure	-	<p>Desk Based Assessment</p> <p>A sub-circular enclosure with a potential entrance to the north was identified through aerial photography and LiDAR imagery. The enclosure had a diameter of 97m.</p> <p>The enclosure was not depicted on any historical or modern mapping.</p> <p>Walkover Survey</p> <p>The sub-circular enclosure was identified as an ephemeral banked partial enclosure that was perceivable from afar. The bank could potentially represent another drove wall within the landscape.</p>	NS 82515 98197 to NS 82567 98170

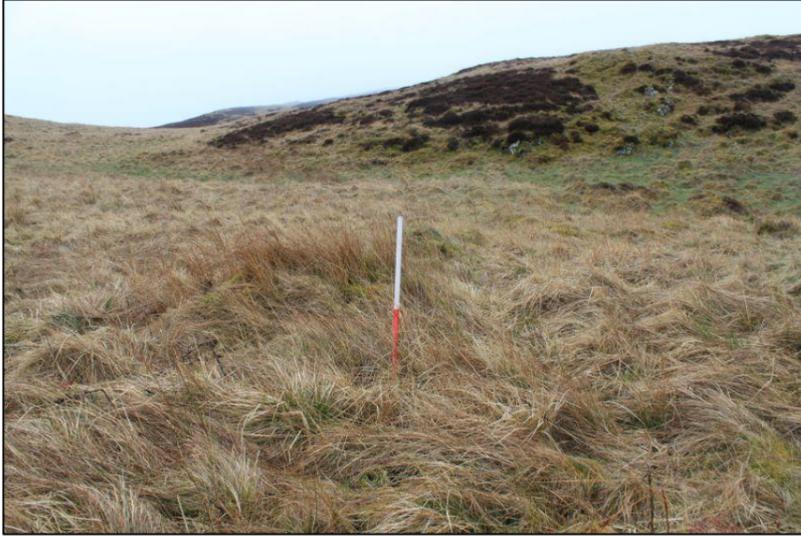
S20	Dumyat Hill Enclosure	Canmore: 47118 SC HER: 1222	<p>Desk Based Assessment</p> <p>A D-shaped enclosure was identified by RCHAMS during a field survey in 1956. The structure was identified as comprising of earthfast boulders with a possible entrance to the west. The enclosure had a diameter of 21.9m. The enclosure was visited by the Ordnance Survey in 1974 and was noted as 'not typical of a sheepfold and there are no other features in the area which it can be associated'.</p> <p>The enclosure was not depicted on any historical or modern mapping, yet it is visible on aerial photography and LiDAR imagery.</p> <p>Walkover Survey</p> <p>The D-shaped enclosure was identified during the walkover as an enclosure comprised of large boulders free of turf with the northeast edge being the nearby stone face of Dumyat slopes. The banks measured an approximate width of 0.7m with a maximum height of 0.4m. The enclosure had an approximate diameter of 21m.</p>	NS 82757 98353 to NS 82766 98341

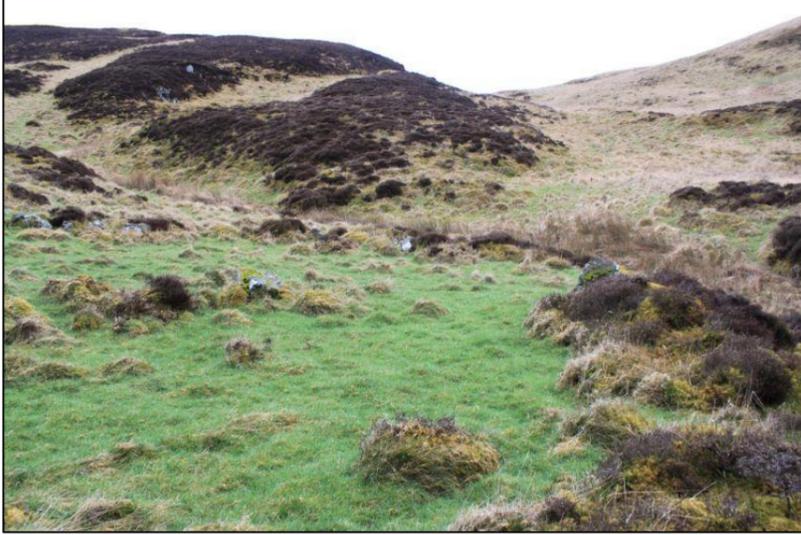
No	Site	HER Ref:	Description	NGR	Image from Site Inspection
S21	Sheriffmuir Road Enclosure	-	<p>Desk Based Assessment</p> <p>A sub-rectangular enclosure was identified through aerial photography and LiDAR imagery. The enclosure measures 10.2m from WSW to ENE by 8.3m transversely. The enclosure was not depicted on historical or modern mapping.</p> <p>Walkover Survey</p> <p>A sub-rectangular enclosure was identified as a turf covered enclosure. The banks had a maximum width of 1.1m and the enclosure had a surviving height of 0.2m. The enclosure was located in a slight wind buffer nearby an unnamed road that runs from northwest to southeast along the northeastern boundary of the assessment area.</p>	NS 82172 99146

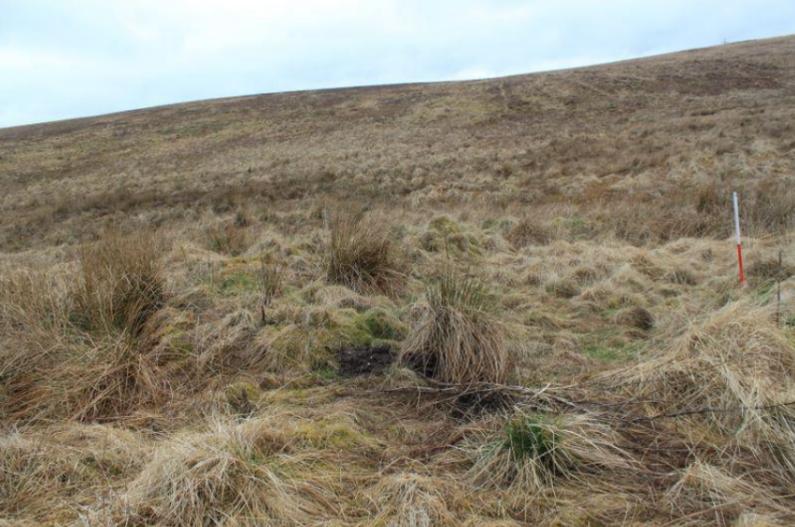
S22	Pendreichmuir Farmstead	-	<p>Desk Based Assessment</p> <p>A single farm building with a single large enclosure and livestock pens was depicted as 'Pendreichmuir' on the 1st ed Ordnance Survey (1865/66). The structure is similar depicted on the 2nd ed Ordnance Survey (1899-1901) however, it is noted as 'Pendreichmuir Cottage' with the presence of a well to the south of the structure.</p> <p>A potential two compartment structure is identified through LiDAR imaging as resting against the western edge of the assessment area.</p> <p>Walkover Survey</p> <p>The farmstead was identified as a NW gable end with associated stone banks running from the structure. The edge of the assessment area rests against the gable end which is leaning towards the N. The stone banks in the area that initially run to the N away from the farmstead before curving towards the E and then curving back towards the SW to return to the farmstead, appear to be connected to the farm potentially as part of a larger agricultural system.</p>	NS 80890 99075

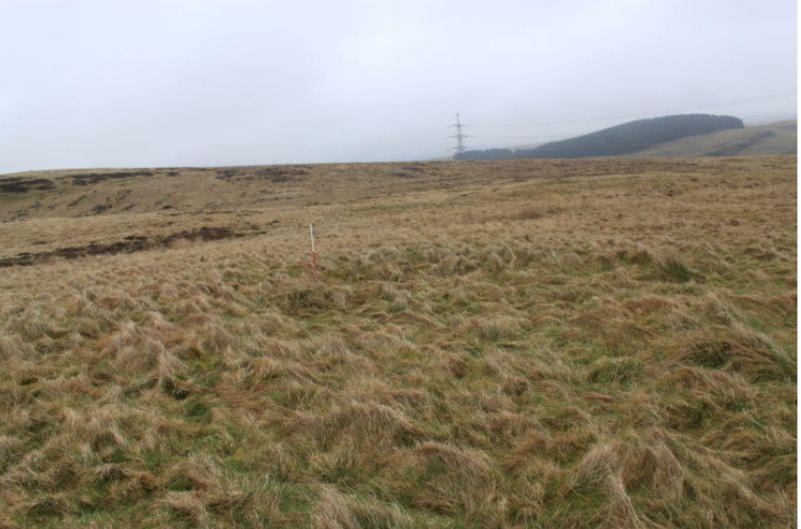
S24	Wharry Burn Track	-	<p>Desk Based Assessment</p> <p>A track was illustrated on the 1st ed Ordnance Survey (1865/66) running away from Pendreichmill (S16) to the north-west before curving to run towards the south-west where it forks into two roads, one running north outside of the assessment area and the other running south before exiting the assessment area. The track was similarly depicted on the 2nd ed Ordnance Survey map (1899-1901).</p> <p>The track is not depicted on modern mapping, yet it is visible on aerial photography and LiDAR imagery.</p> <p>Walkover Survey</p> <p>The track was identified as a stoney area between two slight banks that primarily utilised a natural valley between two small hills. The track had an approximate width of 4.7m and was used for modern farm access further to the south.</p>	NS 8191 00299 to NS 81212 00751

113. Wharry Burn track **S24** was first depicted on the 1st edition Ordnance Survey. It does not make a significant contribution to the historic landscape character, is unlikely to contain complex archaeological information and hence is ascribed Other significance. **No action** is recommended.

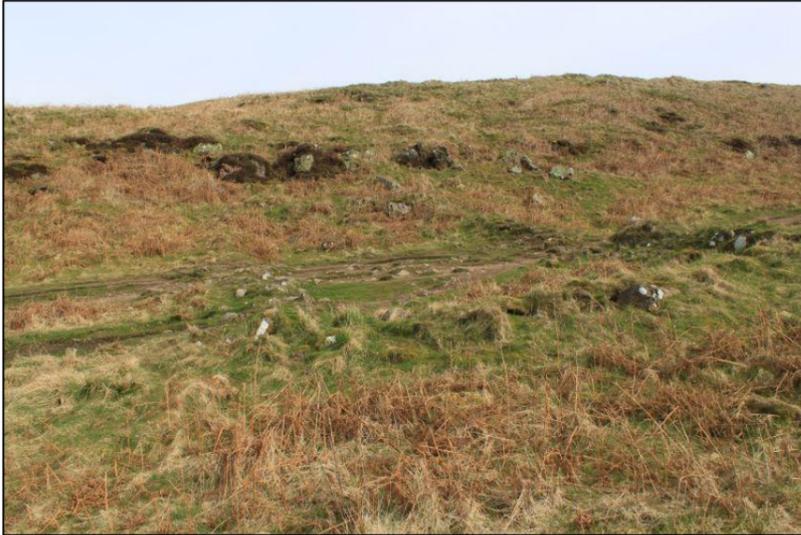
S26	Sheriffmuir Road Enclosure	-	<p>Desk Based Assessment</p> <p>A sub-rectangular enclosure was identified on the 1st edition Ordnance Survey (1865/66). The enclosure measures 20.8m from NNE to SSW by 19.2m transversely. The enclosure sits partly within Rig DJ.</p> <p>The enclosure was not depicted on r modern mapping and is visible on LiDAR imagery.</p> <p>Walkover Survey</p> <p>The enclosure was not identified during the walkover survey, due to dense tall grass.</p>	NS 81326 98302

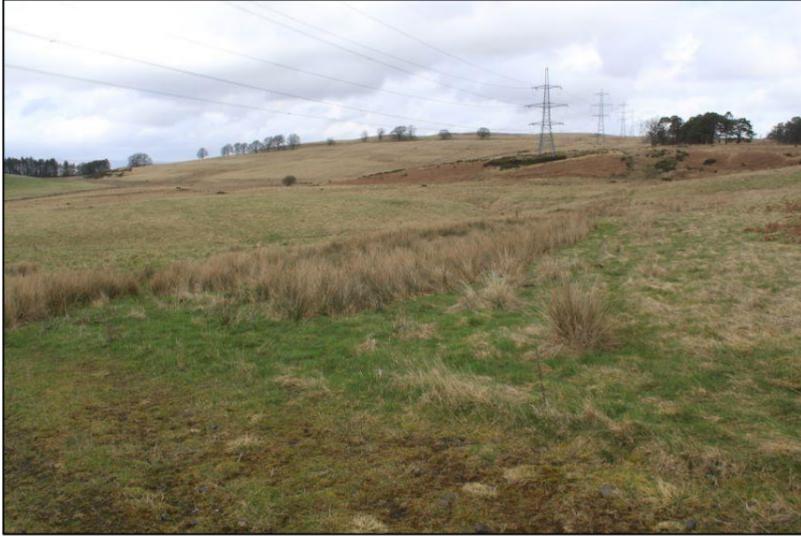
S27	Cuparlaw Wood Mound	-	<p>Desk Based Assessment</p> <p>A semi-circular mound was identified through aerial photography and LiDAR imagery. The mound sits 72m to the northeast of a prehistoric cairn S3. The mound measures 12.9m from NW to SE by 5.2m transversely.</p> <p>The mound was not depicted on any historical or modern mapping.</p> <p>Walkover Survey</p> <p>The semi-circular mound was identified during the walkover with an associated rectangular depression that ran from the northern edge of the mound. The mound measured approximately 12.5m from NW to SE by 5m transversely. The trench identified measured 5.9m from NW to SE by 2.1m transversely with a depth of 0.25m.</p>	NS 81313 99425

115. Pendreich mound **S27** is an irregular shaped mound the origin of which is uncertain. As such, it has been ascribed Other significance. **No action** is recommended. However, forestry operations should avoid unnecessary disturbance to this upstanding feature.

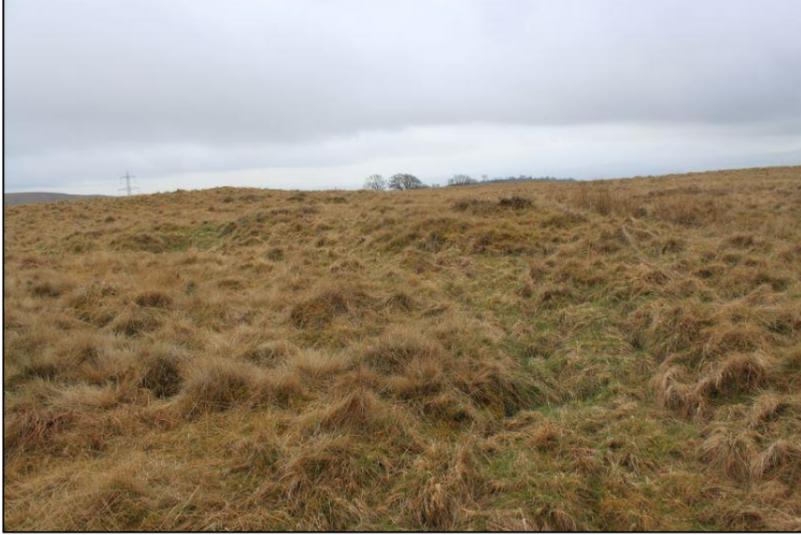
No	Site	HER Ref:	Description	NGR	Image from Site Inspection
S28	White Hill Enclosure	-	<p>Desk Based Assessment</p> <p>A sub-rectangular enclosure was identified through LiDAR imagery. The enclosure measures 7.8m from WNW to ESE by 5.2m transversely.</p> <p>The enclosure was not depicted on historical or modern mapping.</p> <p>Walkover Survey</p> <p>The sub-rectangular enclosure was identified as a possible small lambing pen during the walkover. The banks comprised turf banks measuring a width of 0.8m by a maximum height of 0.2m.</p>	NS 81100 97754

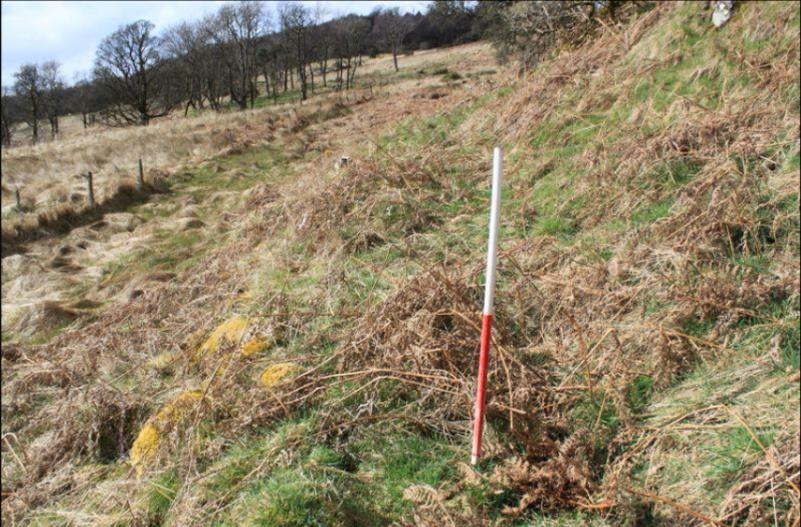
S30	Dumyat Hill Trench	-	<p>Desk Based Assessment</p> <p>A flattened W-shaped trench was identified through aerial photography and LiDAR imagery. The trench measures a length of 31m from NW to SE with a width of 5.2m. The trench sits 17.4m to the southeast of a possible cairn S31.</p> <p>The trench was not depicted on historical or modern mapping.</p> <p>Walkover Survey</p> <p>The trench was identified during the walkover as a partly turf covered linear depression. The depression had a maximum depth of 0.28m and had a boggy stone filled base. The depression appeared relatively modern in construction and resided 17.4m from the cairn S31.</p>	NS 82291 98527

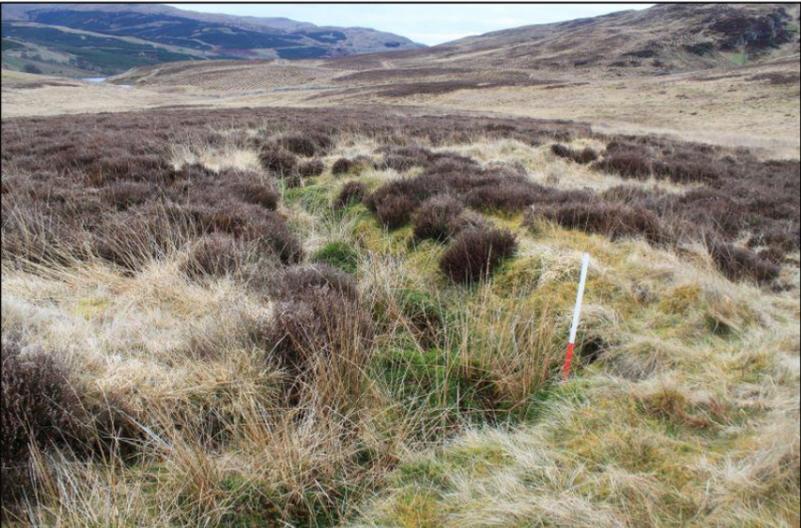
No	Site	HER Ref:	Description	NGR	Image from Site Inspection
S31	Dumyat Hill Cairn	-	<p>Desk Based Assessment</p> <p>A possible cairn was identified on LiDAR imagery. The cairn sits 17.4m to the northwest of trench S30.</p> <p>The cairn is not depicted on any historical or modern mapping.</p> <p>Walkover Survey</p> <p>The cairn was identifiable in the landscape as a turf covered mound surrounded by heather. The mound measured 4.45m from northeast to southwest by 7.5m transversely. The cairn had a maximum surviving height of 0.55m and sat atop an unnamed summit.</p>	NS 82267 98850

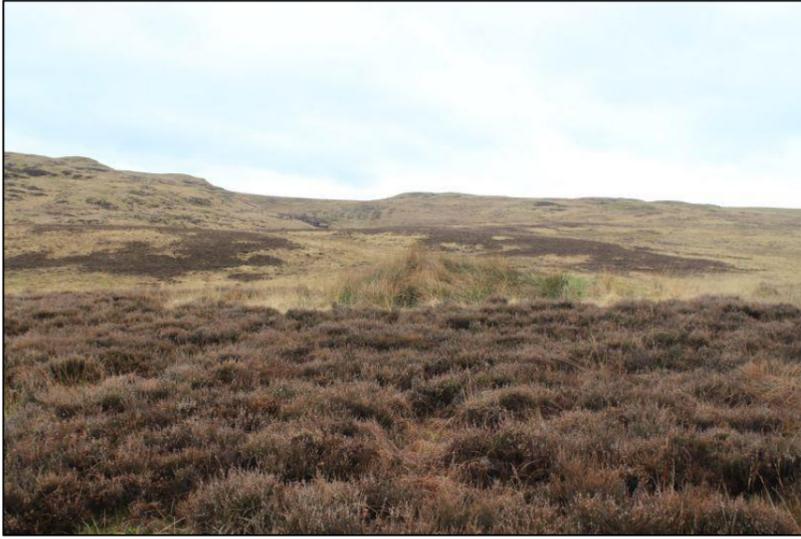
S32	Pendreich Standing Stone	-	<p>Desk Based Assessment</p> <p>-</p> <p>Walkover Survey</p> <p>A possible standing stone was identified to the NE of S4, the stone appeared to have fallen. The stone was sub-triangular in shape, measuring a height of 0.73m and 1.45m from NE to SW by 1.9m transversely. There was a small earthen 'curb' that measured a height of 0.2m.</p>	NS 81394 99720

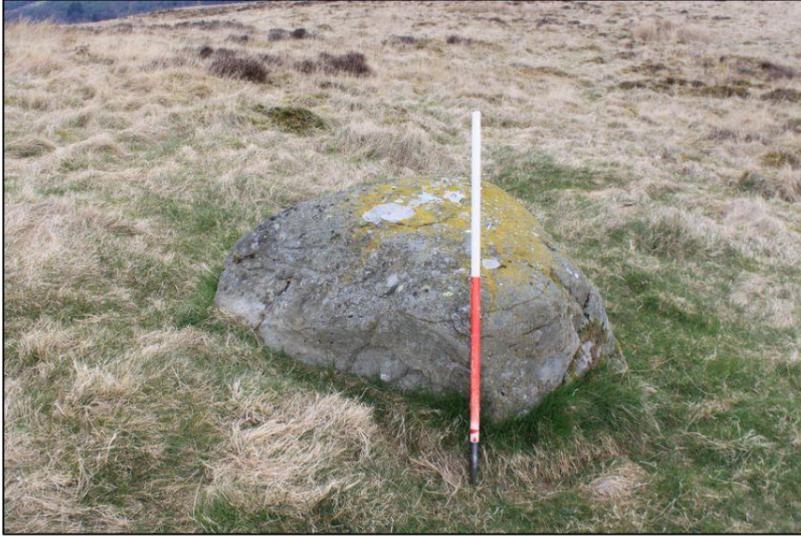
S33	Dumyat Hill Stone working site	Canmore: 47140 SC HER: 1901.02	<p>Desk Based Assessment</p> <p>A 'chipping-floor' has been identified by MacFadzean during field survey in 1984. The collection produced one large struck flake and other artefacts. There is no physical depression identifiable on aerial photography or LiDAR imagery.</p> <p>Walkover Survey</p> <p>The location of the 'chipping floor' rests against a path towards the summit of Dumyat directly in front of a bedrock outcrop. No evidence of stone working was identified at the site due to the covering of grass.</p>	NS 81450 97880

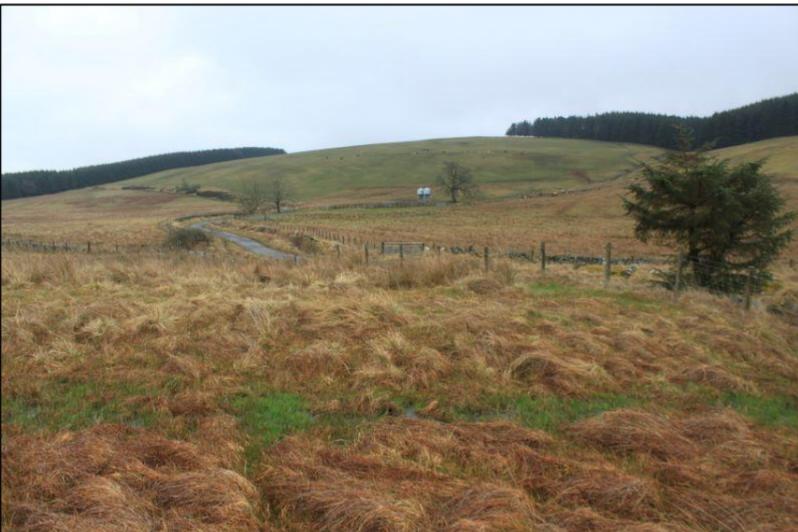
No	Site	HER Ref:	Description	NGR	Image from Site Inspection
S37	Parsonley Farmstead	-	<p>Desk Based Assessment</p> <p>A farmstead named 'Parsonley' is depicted on John Stobie's 'The counties of Perth and Clackmannan' (1783). The farm sits to the northeast of Pendreichmill and is represented as two structures.</p> <p>The farmstead was not depicted on any other historical or modern mapping. No evidence of the farmstead was identifiable on aerial or LiDAR imagery.</p> <p>Walkover Survey</p> <p>No evidence of the farmstead or associated banks was identified in the location. Three quarries were identified within the area.</p>	NS 81723 00644

114. The farmsteads of Bog **S36** and Parsonley **S37** were depicted in the late 18th century but with poor locational information and no identifiable field monuments tied to them. As such, they have been ascribed Other significance. **No action** is recommended.

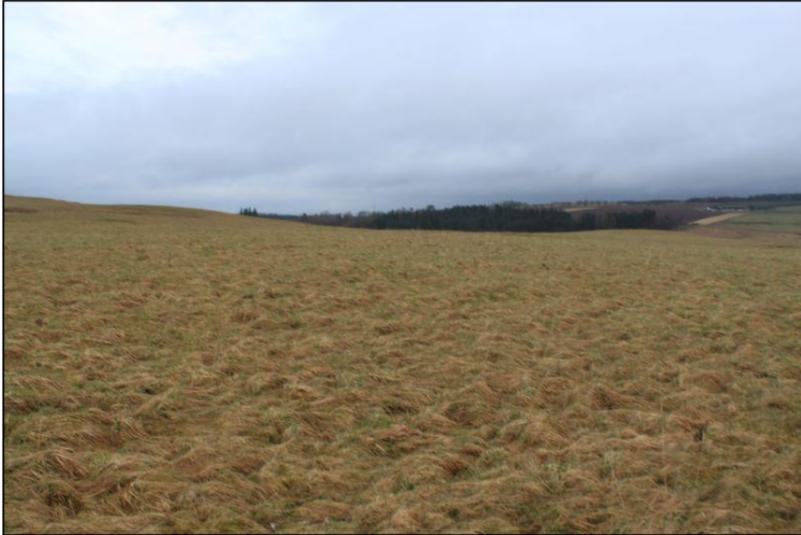
S38	Sheriffmuir Road Cairn	-	<p>Desk Based Assessment</p> <p>-</p> <p>Walkover Survey</p> <p>During the walkover survey, a possible prehistoric funerary cairn was identified 19m to the immediate north of one of the overhead towers for the Beaully Denny Overhead line. The cairn measured 6m from E to W by 7.5m with a maximum height of 0.35m.</p>	NS 81713 99723

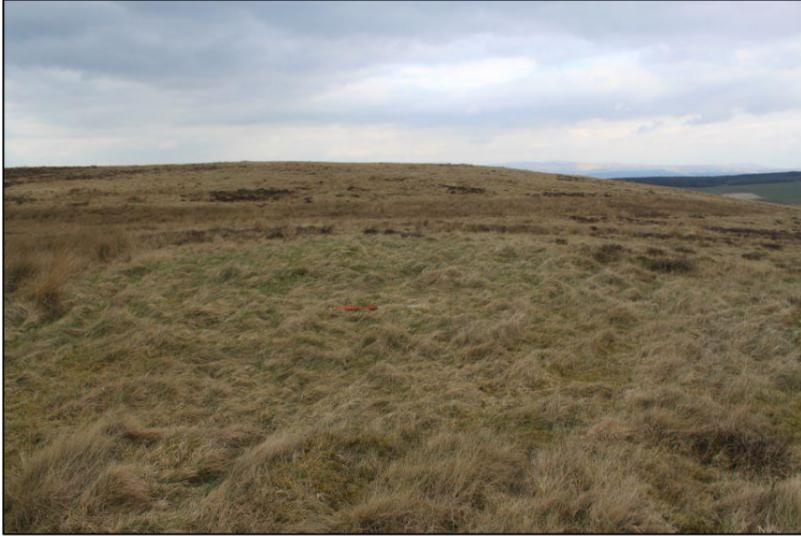
S39	Fossachie Cairn	-	<p>Desk Based Assessment</p> <p>-</p> <p>Walkover Survey</p> <p>During the walkover survey, a possible prehistoric funerary cairn was identified 30m to the south of Fossachie S5. The cairn measured 3.6m from NNW to SSE by 4.2m with a maximum height of 0.6m.</p>	NS 82148 97375

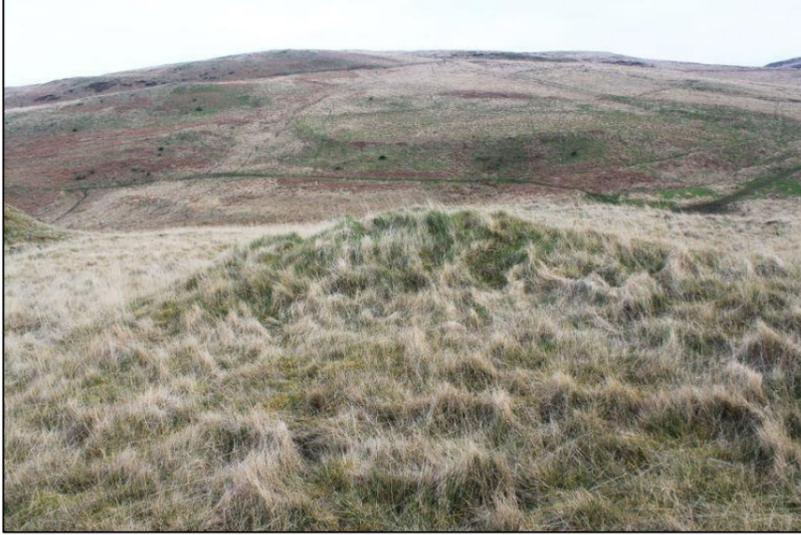
No	Site	HER Ref:	Description	NGR	Image from Site Inspection
S40	Pendreich Standing Stone	SC HER: 4966	<p>Desk Based Assessment</p> <p>A standing stone is noted in the Historic Environment Record for Stirling. The stone is located close to the three scheduled prehistoric cairns in the landscape (S2 & S3).</p> <p>The standing stone is not depicted on any historical or modern mapping and is not visible on LiDAR imagery. Two stones are faintly visible on aerial photography.</p> <p>Walkover Survey</p> <p>A possible standing stone was identified during the walkover. Two large stones lay on their sides, one measuring 1.52m from NE to SW by 0.83m with a height of 0.36m and one measuring 1.65m from NE to SW by 0.76m with a height of 0.52m. The stones do appear natural in creation and do not appear to have been standing upright at any point.</p>	NS 81117 99309

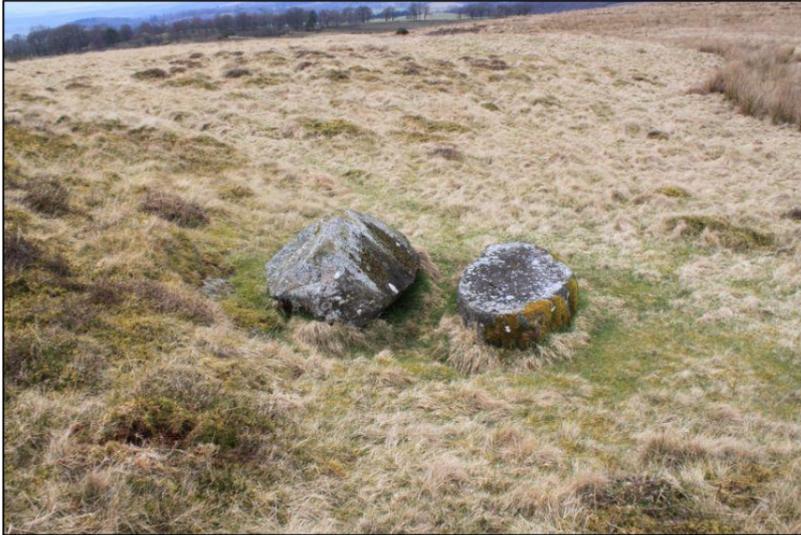
S41	Pendreich Sheepfold	SC HER: 4963	<p>Desk Based Assessment</p> <p>A 'hut' is noted in the Historic Environment Record for Stirling. The 'hut' is located close to the three scheduled prehistoric cairns in the landscape (S2 & S3).</p> <p>The hut is not depicted on any historical or modern mapping. The 'hut' is visible on LiDAR and aerial imagery.</p> <p>Walkover Survey</p> <p>A possible enclosure was identified during the walkover resting against a turf covered bank. The enclosure was sub-circular in construction and comprised turf covered banks. The enclosure had a diameter of 6.5m with the banks measuring 1.3m in width and a maximum height of 0.35m.</p>	NS 81148 99288

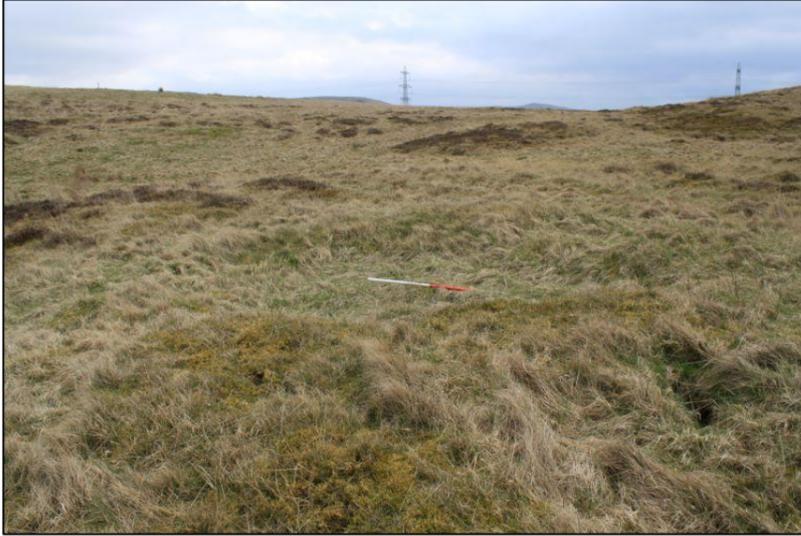
S42	Sheriffmuir Road Livestock Pen	-	<p>Desk Based Assessment</p> <p>A rectangular sheepfold was depicted on the 2nd Ordnance Survey 25 inch to a mile map (1897). The sheepfold had two compartment and rested against two roads, Sheriffmuir Road and an unnamed road that runs from NW to SE. The sheepfold is depicted on modern mapping as 'Livestock Pen'.</p> <p>No evidence for the livestock pen is seen on aerial or LiDAR imagery.</p> <p>Walkover Survey</p> <p>Two large sleepers were embedded in the ground where the livestock pen should reside. No other evidence of a livestock pen was identified.</p>	NS 81056 97708

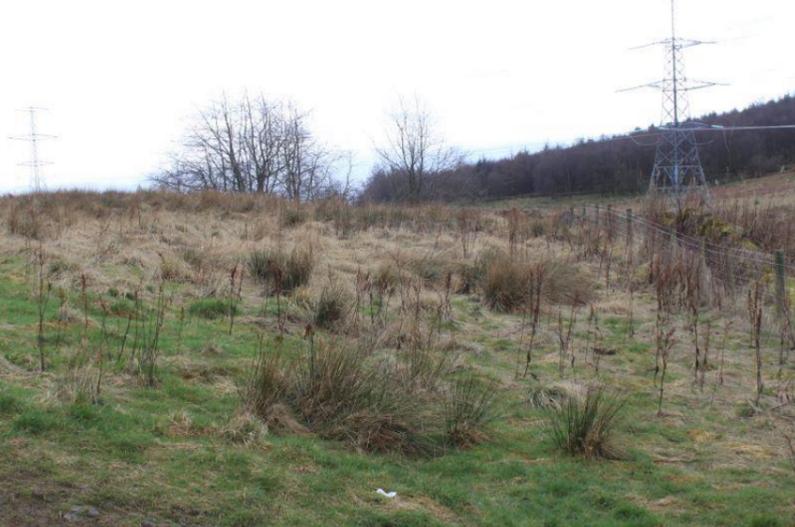
S44	Pendreichmill Banks	-	<p>Desk Based Assessment</p> <p>Multiple partial field banks were recorded on the 1st edition Ordnance Survey in the northern area, particularly surrounding Pendreichmill S16. The field banks and more were identified on aerial and LiDAR imagery. The field banks and associated rig blocks appear to be potential field systems.</p> <p>The field banks are not depicted on any other historical or modern mapping.</p> <p>Walkover Survey</p> <p>The field banks in the northern area were predominately turf banks with one dry-stone bank covered by turf and one turf bank with a post-and-wire fence atop. The banks measured a width of between 1m to 1.4m and had a height of between 0.2m and 0.4m.</p>	-

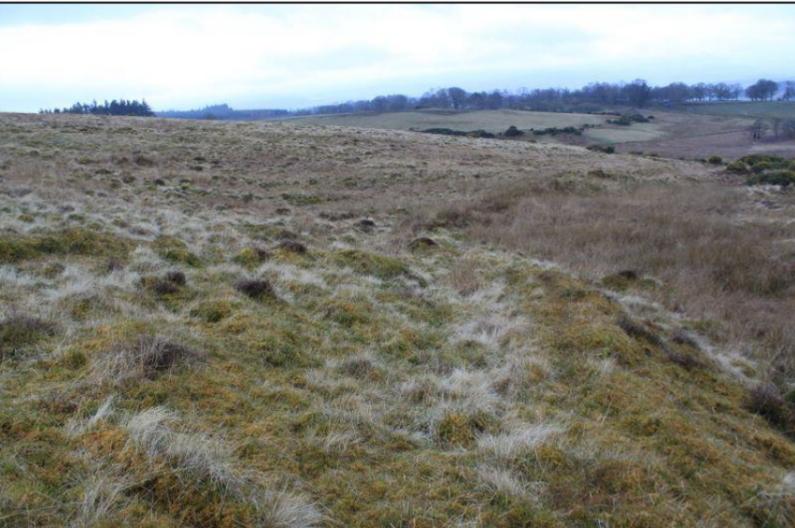
S45	Pendreichmuir Banks	-	<p>Desk Based Assessment</p> <p>Multiple partial field banks were recorded on the 1st edition Ordnance Survey in the western area, particularly surrounding Pendreichmuir S22. The field banks and more were identified on aerial and LiDAR imagery. The field banks and associated rig blocks appear to be potential field systems.</p> <p>The field banks to the northwest of Pendreichmuir are not depicted on any other historical or modern mapping, however, the banks running from Pendreichmuir S22 are depicted on modern mapping.</p> <p>Walkover Survey</p> <p>The field banks to the north-west of Pendreichmuir were turf banks, whereas the field banks to the immediate north-east of Pendreichmuir S22 are a mix of dry-stone walls covered in turf and trees and turf banks. The banks measured a width of between 1m to 1.4m and had a height of between 0.2m and 0.4m.</p>

90. The field boundaries in the western area (**S45**) encompass a larger area with clearer field systems in particular the collection of rig blocks to the northwest (Rig **CL** to **CQ** & Rig **CS** and **CT**) and the immediate northeast (Rig **CU** to **DB**) of Pendreichmuir **S22**. The rig is a mix of narrow low rig and broad rig which potentially shows a change in the agricultural techniques and systems during their use. The field boundaries of **S45** appear to connect to Pendreichmuir **S22**, particularly the field boundaries to the northeast where the banks curve directly from the farmstead creating an enclosed field system. The easternmost field

boundaries with **S45** appear to form an enclosure within Cocksburn Wood which had forestry noted in the area in the 1st edition Ordnance Survey (1865/66).

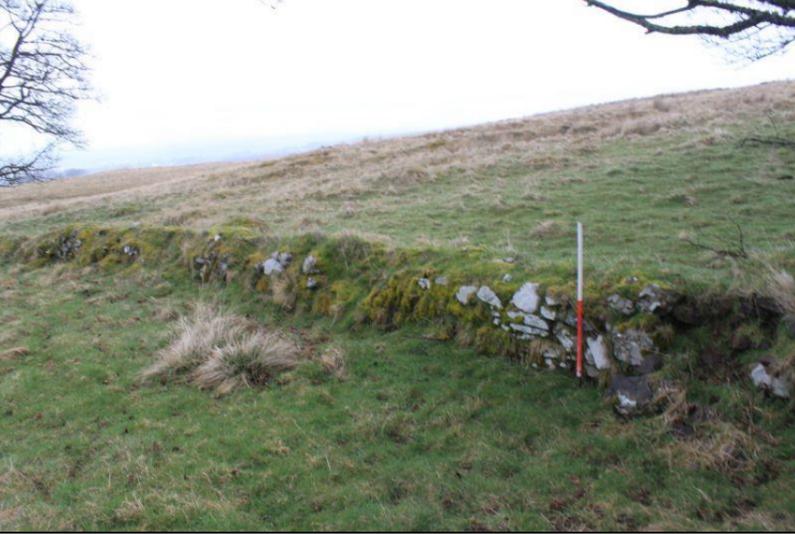
S46	Sheriffmuir Road Banks	-	<p>Desk Based Assessment</p> <p>Five partial field banks were identified on aerial and LiDAR imagery. The field banks with associated rig blocks appear to be a small field system.</p> <p>The field banks are not depicted on any historical or modern mapping.</p> <p>Walkover Survey</p> <p>The five field banks were identified as turf banks measuring between 0.8m to 1.3m with a height of between 0.15m to 0.4m.</p>

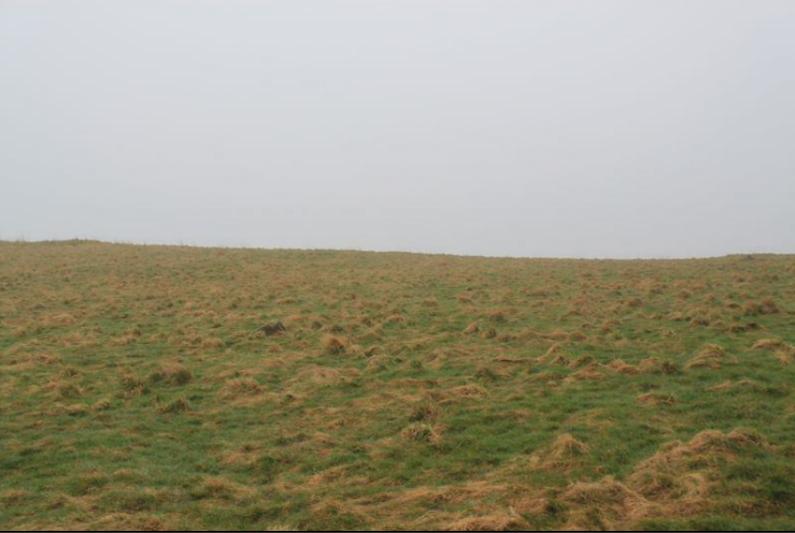
S47	Sheriffmuir Road Banks	-	<p>Desk Based Assessment</p> <p>Two partial field banks were identified on aerial and LiDAR imagery. The field banks with associated rig blocks appear to be a small field system.</p> <p>The field banks are not depicted on any other historical or modern mapping.</p> <p>Walkover Survey</p> <p>The two field banks were ephemeral up close yet identifiable from afar</p>

91. Two smaller areas of field systems are identified closer to Sheriffmuir Road, one to the north (**S46**) and one to the south (**S47**). The northern system **S46** comprises predominately broad rig in Rig areas **BF** to **BK** whereas the southern area **S47** is mostly narrow rig blocks in Rig **J** to **L**.

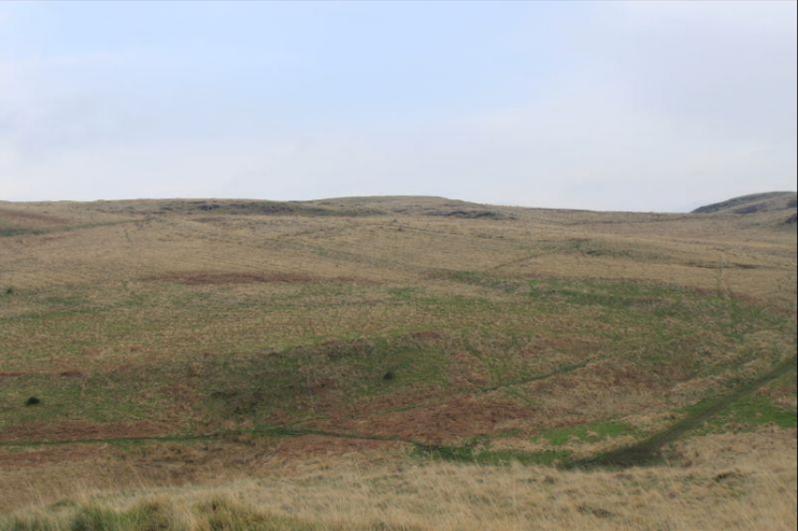
No	Site	HER Ref:	Description	NGR	Image from Site Inspection
S48	Fossachie Banks	-	<p>Desk Based Assessment</p> <p>Multiple partial field banks were identified on aerial and LiDAR imagery. The field banks and associated rig blocks appear to be potential field systems and focus on the settlements of Fossachie S5, Backadykes S11 and unnamed structure S7.</p> <p>Three of the field banks that run from northwest to southeast are depicted on the modern Ordnance Survey.</p> <p>Walkover Survey</p> <p>The field banks were turf banks and create field systems on the slopes around Fossachie S5 and Backadykes S11. The banks measured a width of between 1m to 1.2m and had a height of between 0.2m and 0.4m.</p>
